MACKAS SAND ANNUAL REVIEW 2018

January – December 2018

Prepared by
Umwelt (Australia) Pty Limited
on behalf of
Mackas Sand Pty Ltd

Project Director: **Bret Jenkins**
Project Manager: **Rod Williams**
Report No. **1646/R85**
Date: **March 2019**

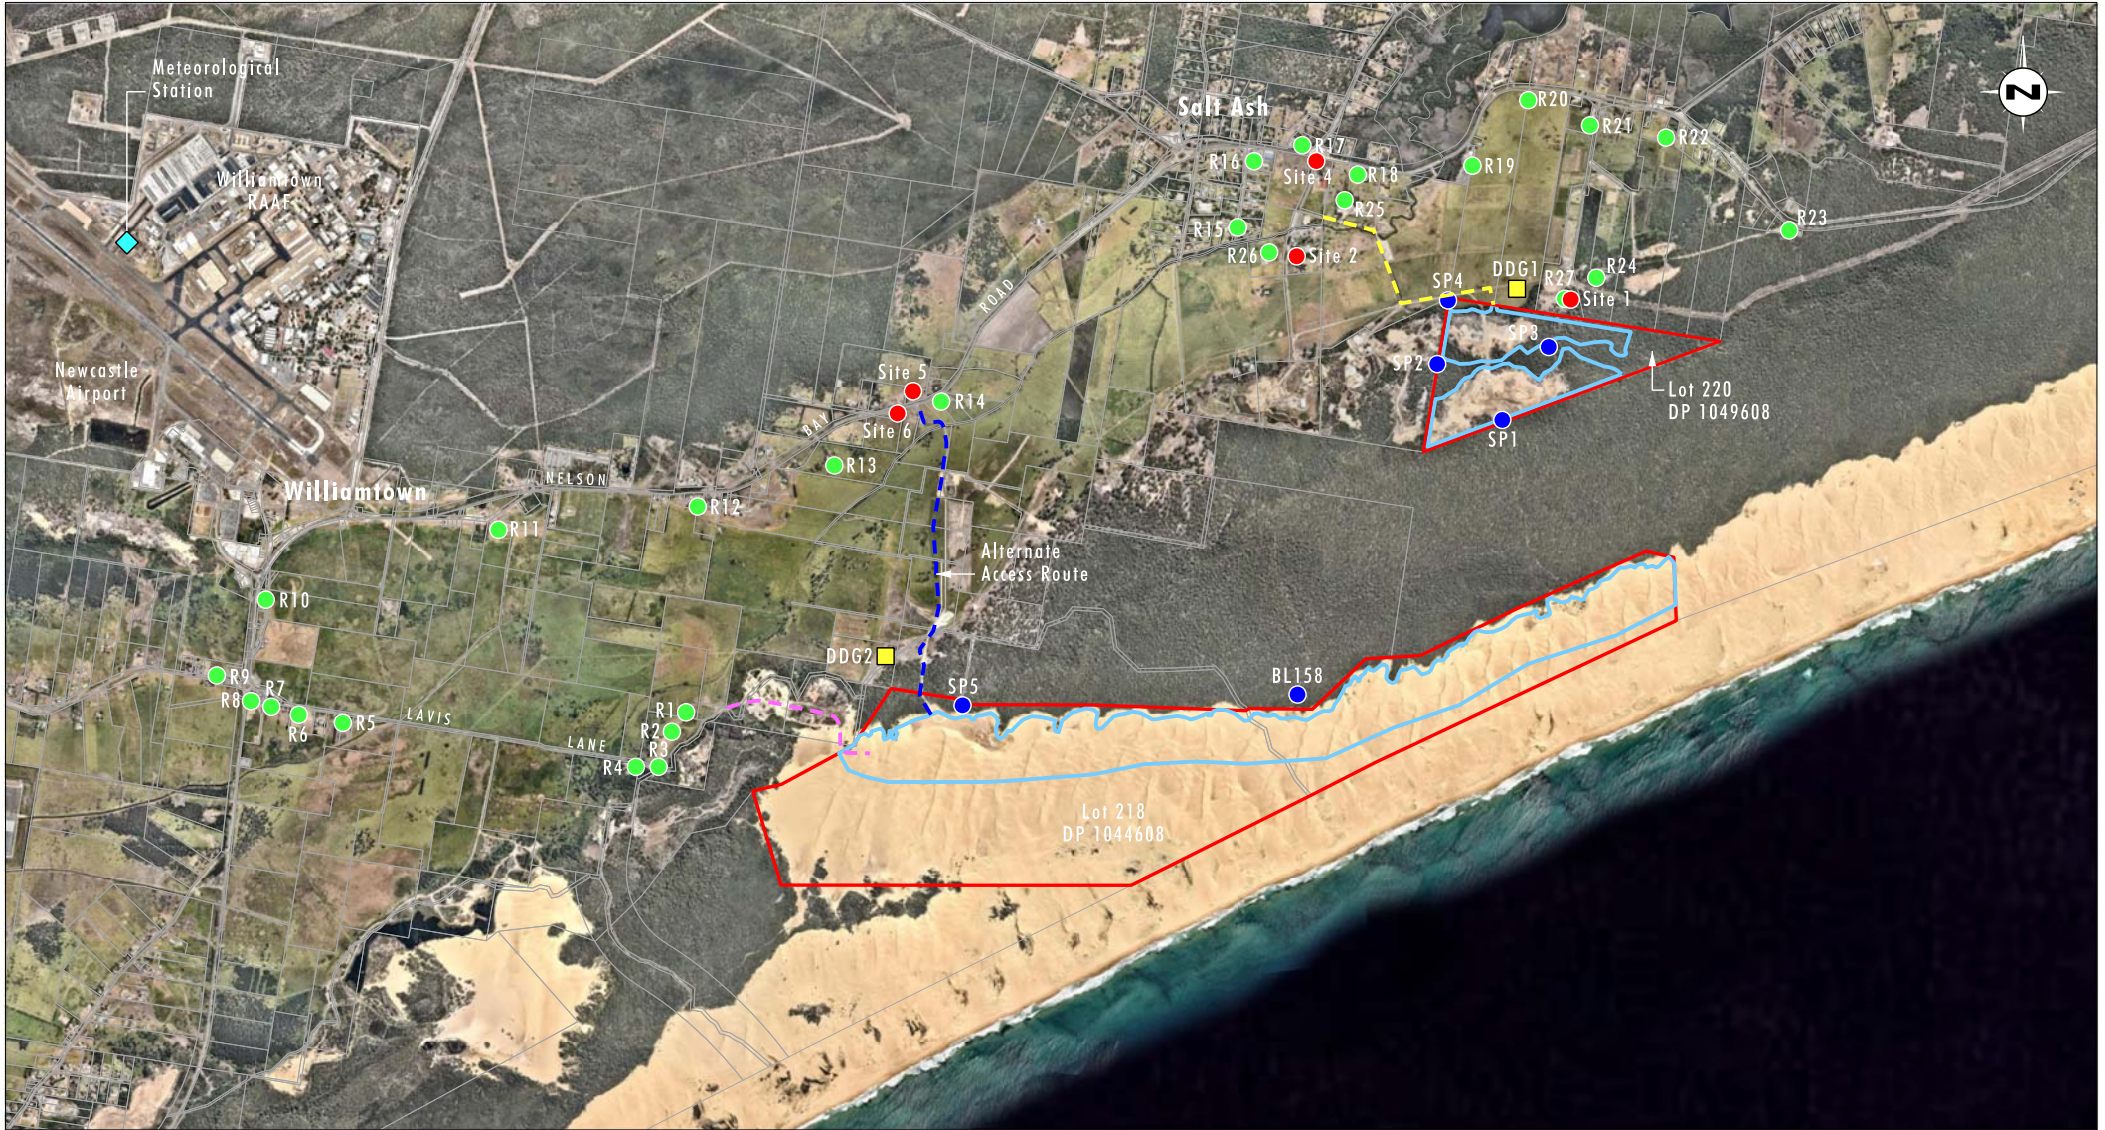
Figure 6.1 shows the Mackas Sand environmental monitoring locations.

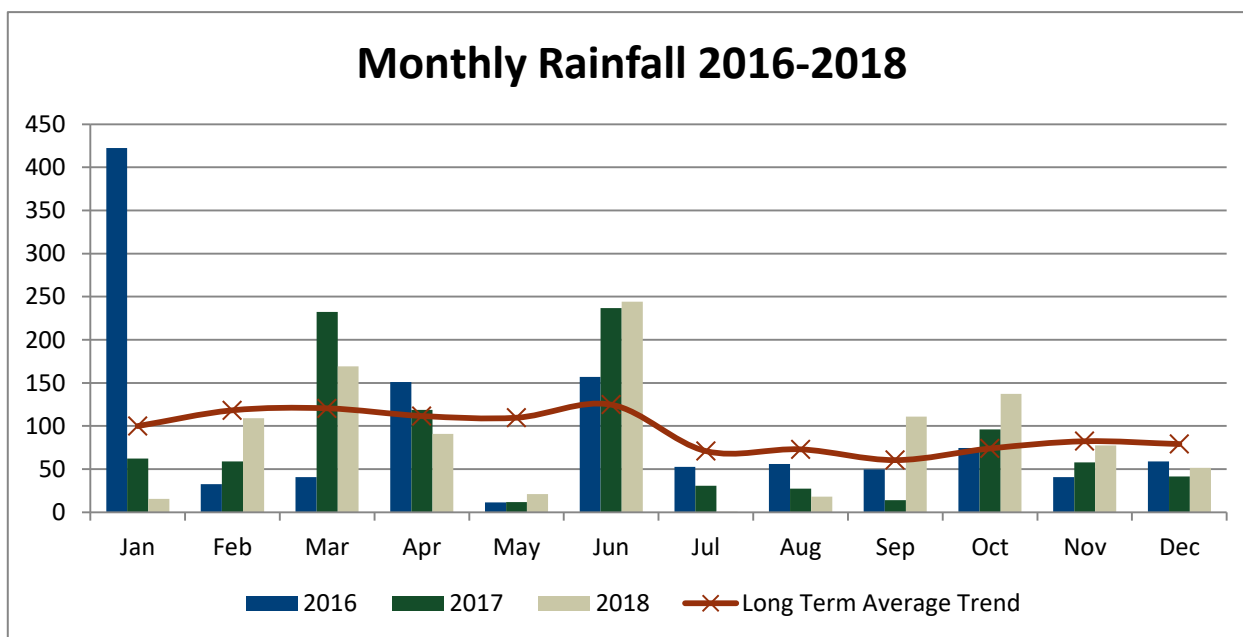
Figure 6.2 Monthly Rainfall 2016-2018

Month	Rainfall (mm)	Highest Daily (mm)	Rain Days (i.e. >0.2 mm)
January	15.4	6.8	4
February	109.0	54.0	10
March	169.2	122.0	9
April	91.0	27.2	11
May	21.1	11.2	4
June	244.2	50.6	18
July	0.6	0.4	1
August	18.2	11.2	3
September	111.0	34.0	11
October	137.4	38.6	11
November	77.6	48.2	5
December	51.4	19.4	9
TOTAL	1046	122	96

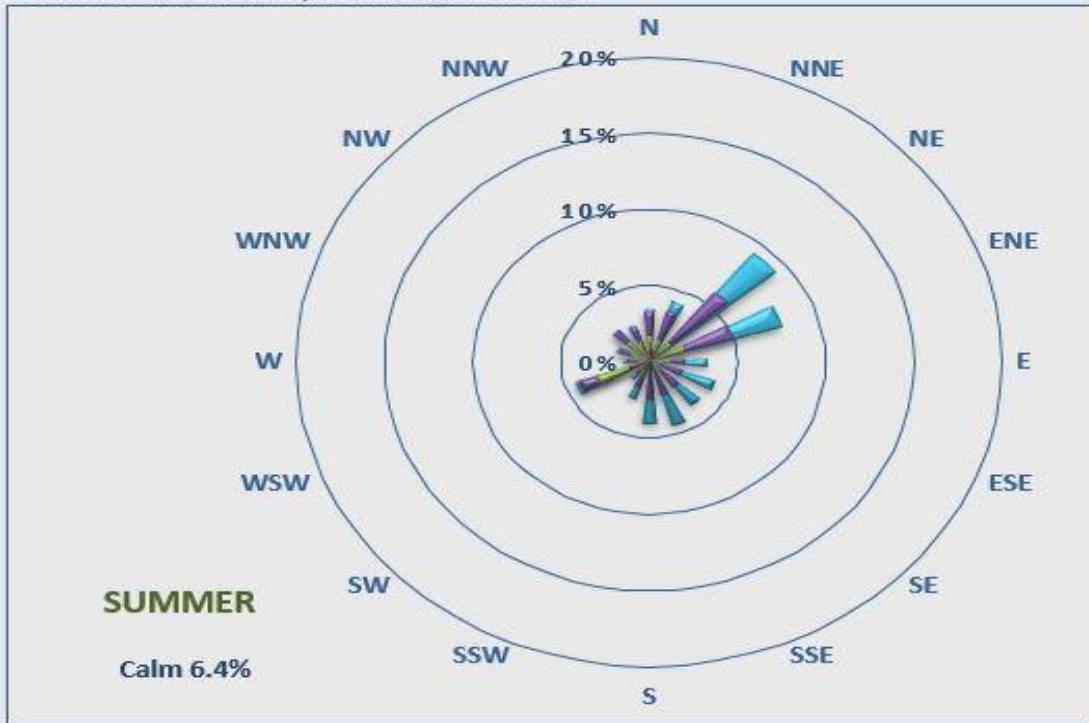
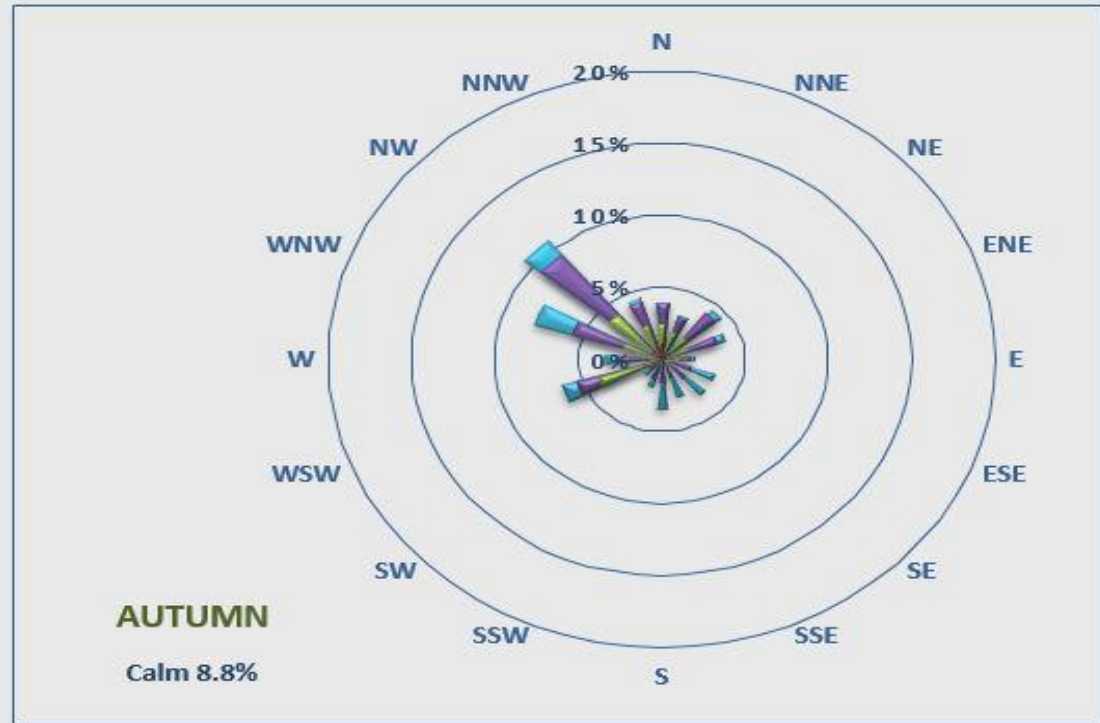
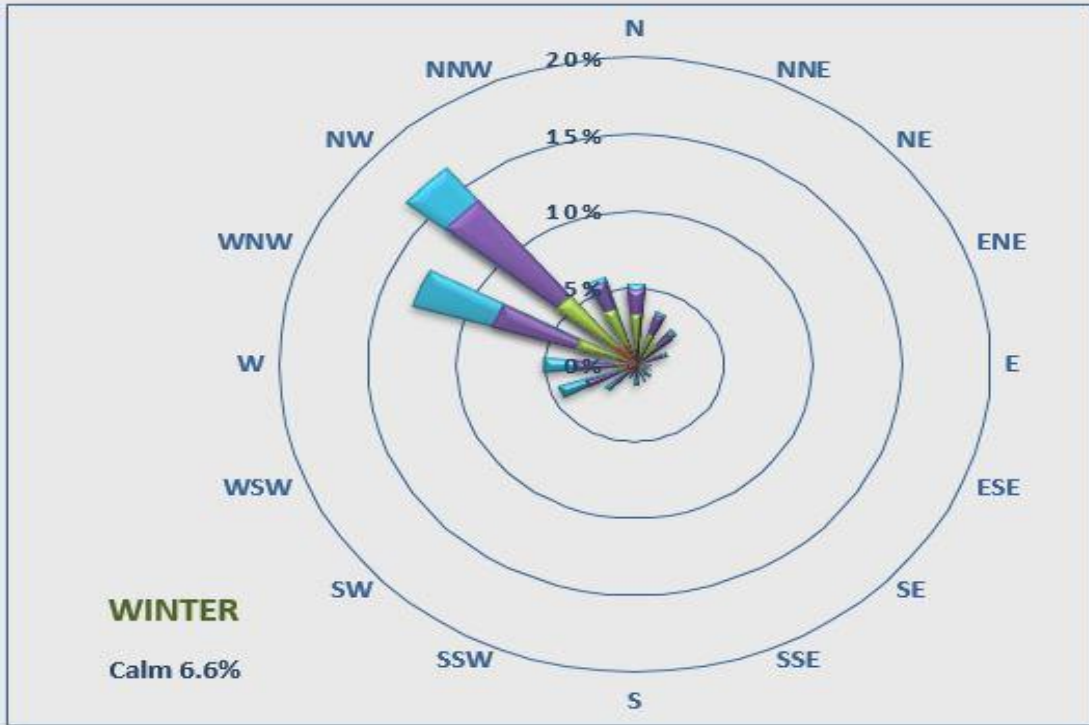
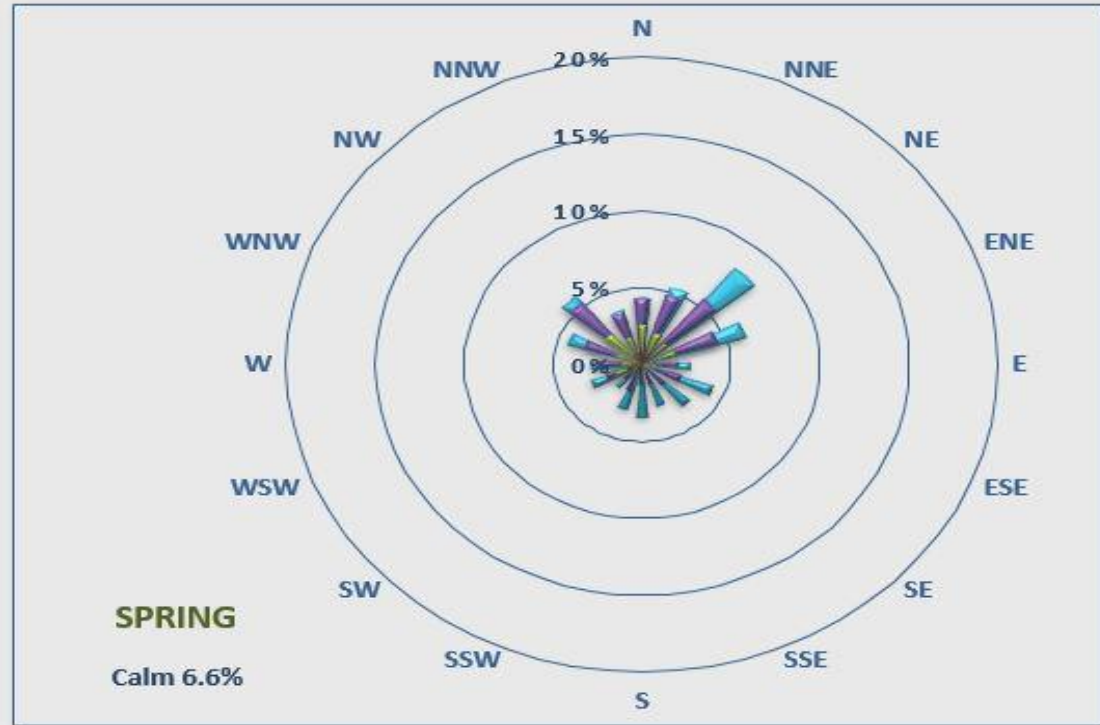
Wind Rose Data

Data Source: Williamstown Airport 01 Jan 2018 to 31 Dec 2018
