## **MACKAS SAND ANNUAL REVIEW 2022**

January–December 2022

| Annual Review Title Block | |
|--|---|
| Name of operation | Mackas Sand Project |

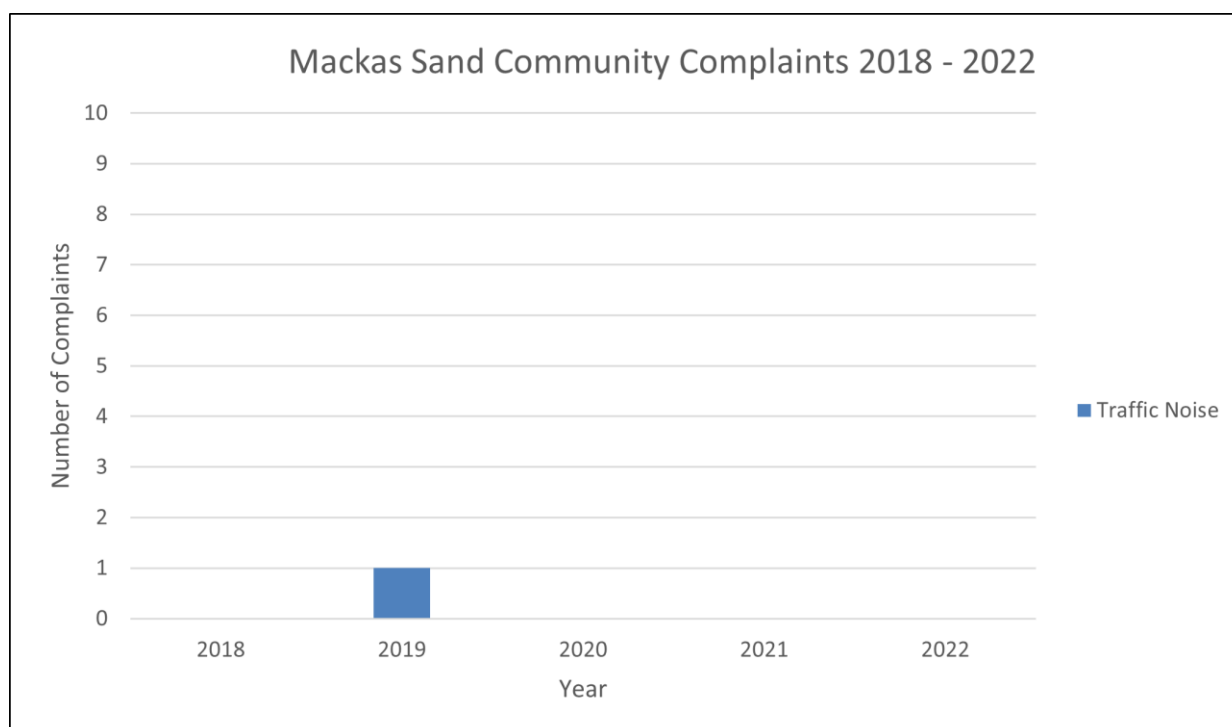
**Figure 9-1** Summary of Mackas Sand Community Complaints from 2017-2022

A summary of community complaints received for the last five reporting periods is displayed in **Figure 9-1**. It is noted that 1 community complaint has been received between 2018 – 2022.
