LANDSCAPE MANAGEMENT PLAN

Including Rehabilitation Management Plan and
Long Term Management Strategy

Prepared by
Umwelt (Australia) Pty Limited
on behalf of
Mackas Sand Pty Limited

Project Director: Luke Bettridge
Project Manager: Dominic Brown
Report No. R93
Date: November 2021

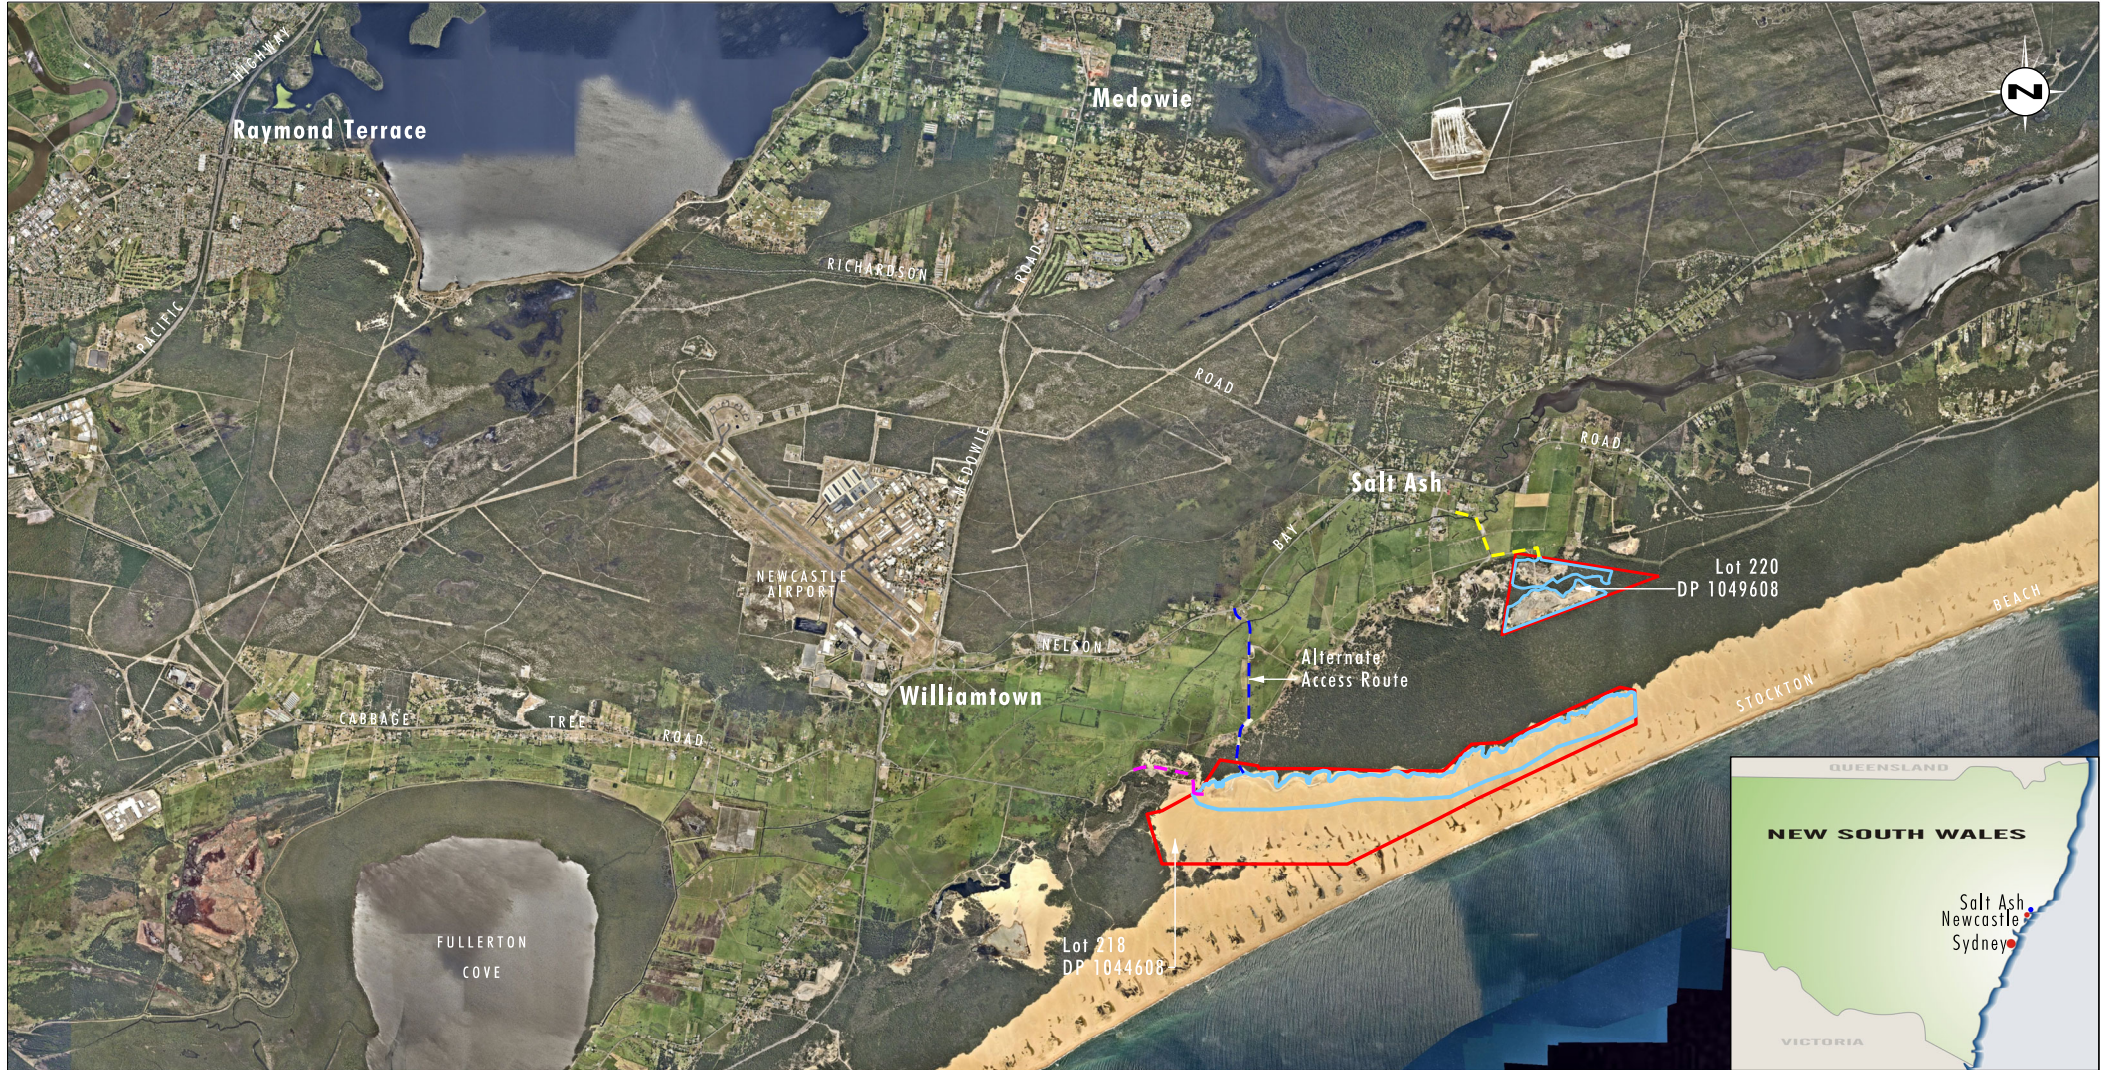
FIGURE 1.1

Locality Plan

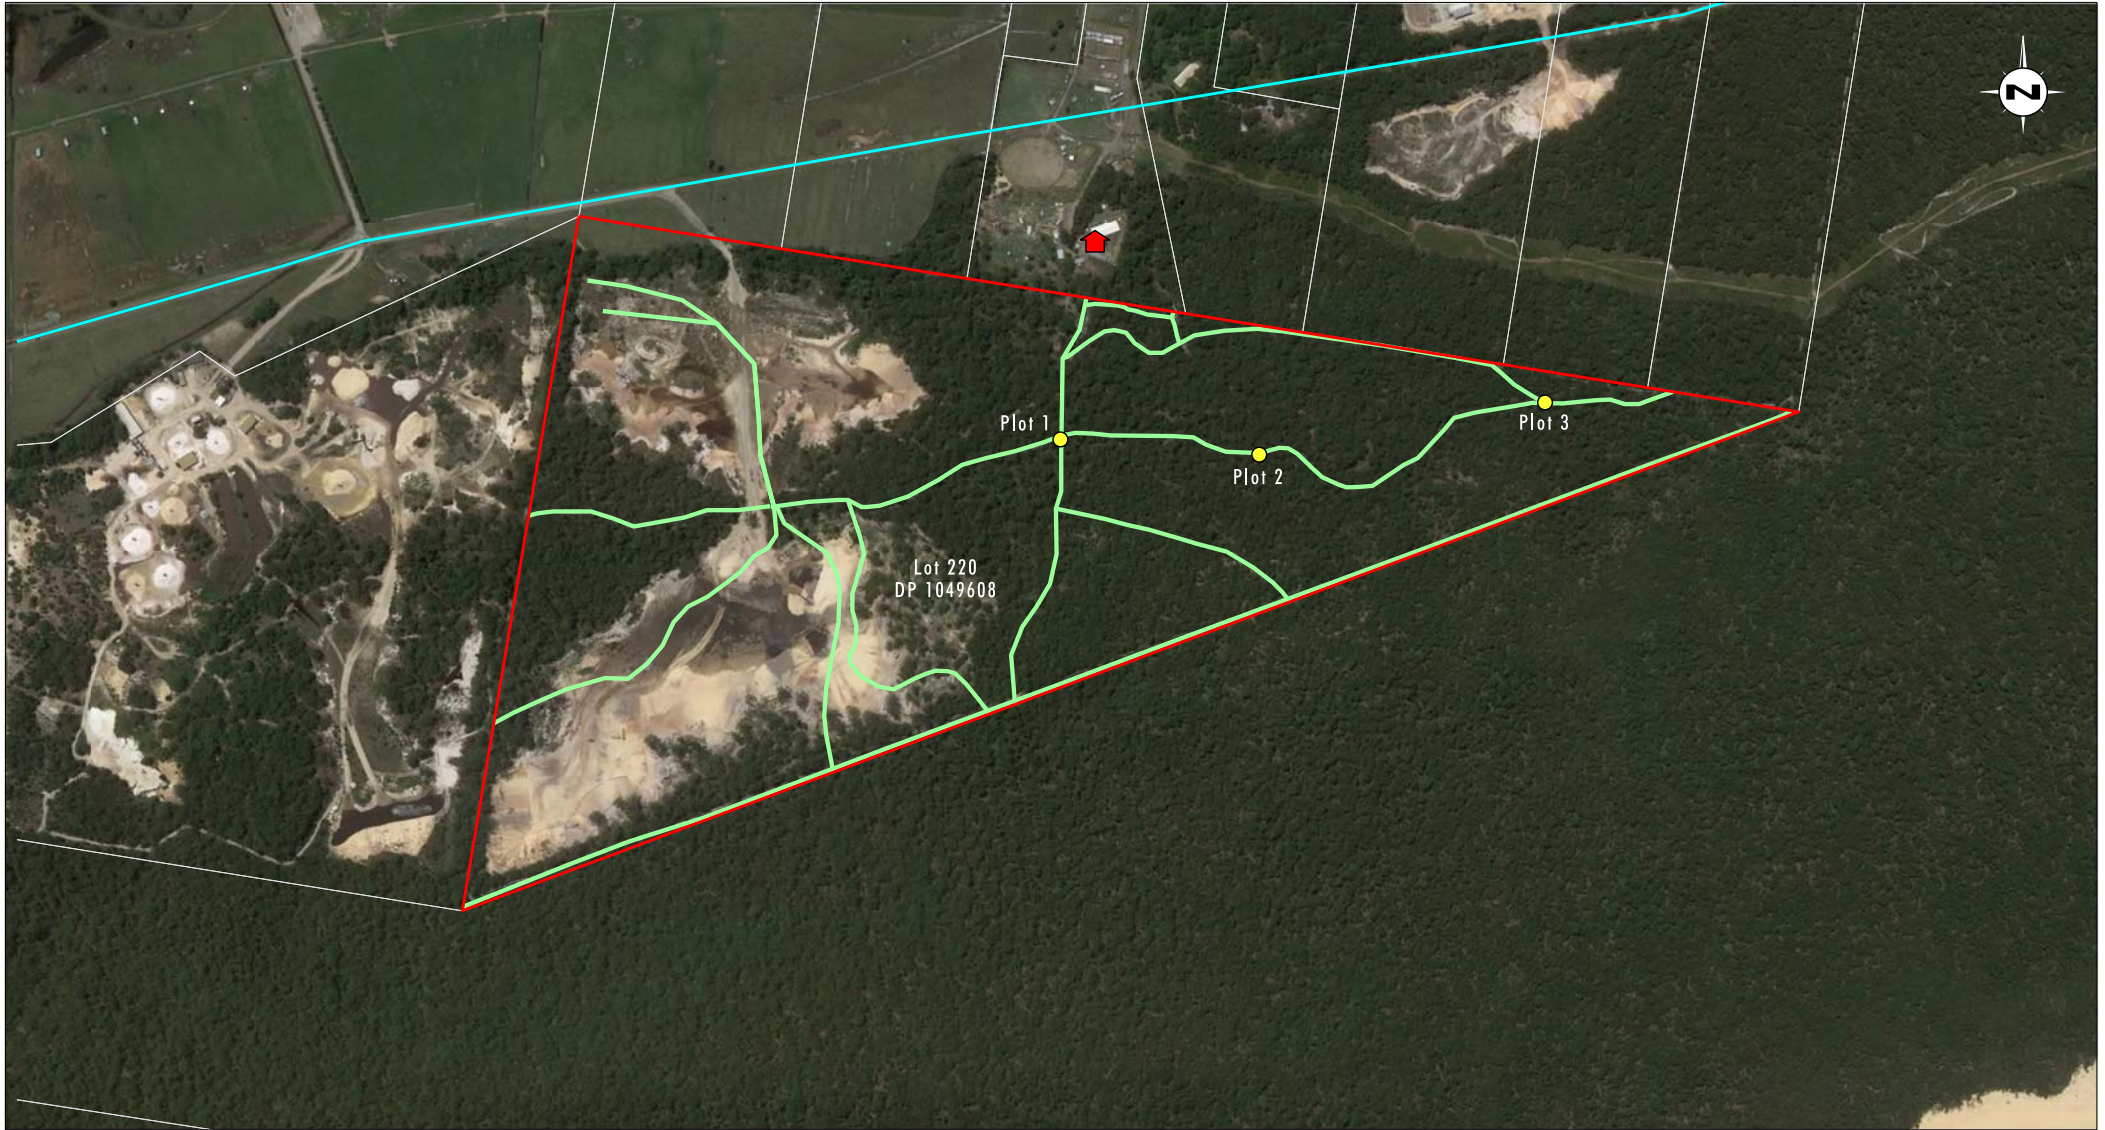
FIGURE 2.1
Lot 220 Features

- Lot 220 Boundary
- 🏠 Hufnagl Residence
- Existing Transmission Line in 20 metre Wide Easement
- Approximate Location of Existing Tracks
- Monitoring Plots
