MACKAS SAND ANNUAL REVIEW 2021

January - December 2021

Name of operation	Mackas Sand Project
Name of operator	Mackas Sand Pty Limited
Development Consent / Project Approval No.	PA 08_0142 (as modified)
Name of holder of development consent/project approval	Mackas Sand Pty Limited
Mining lease No.	No Mining Lease applicable to site under the <i>Mining Act</i> (1992).
Name of holder of mining lease	N/A
Water licence #	N/A
Name of holder of water licence	N/A
MOP/RMP start date	N/A
MOP/RMP end date	N/A
Annual Review start date	1 January 2021
Annual Review end date	31 December 2021

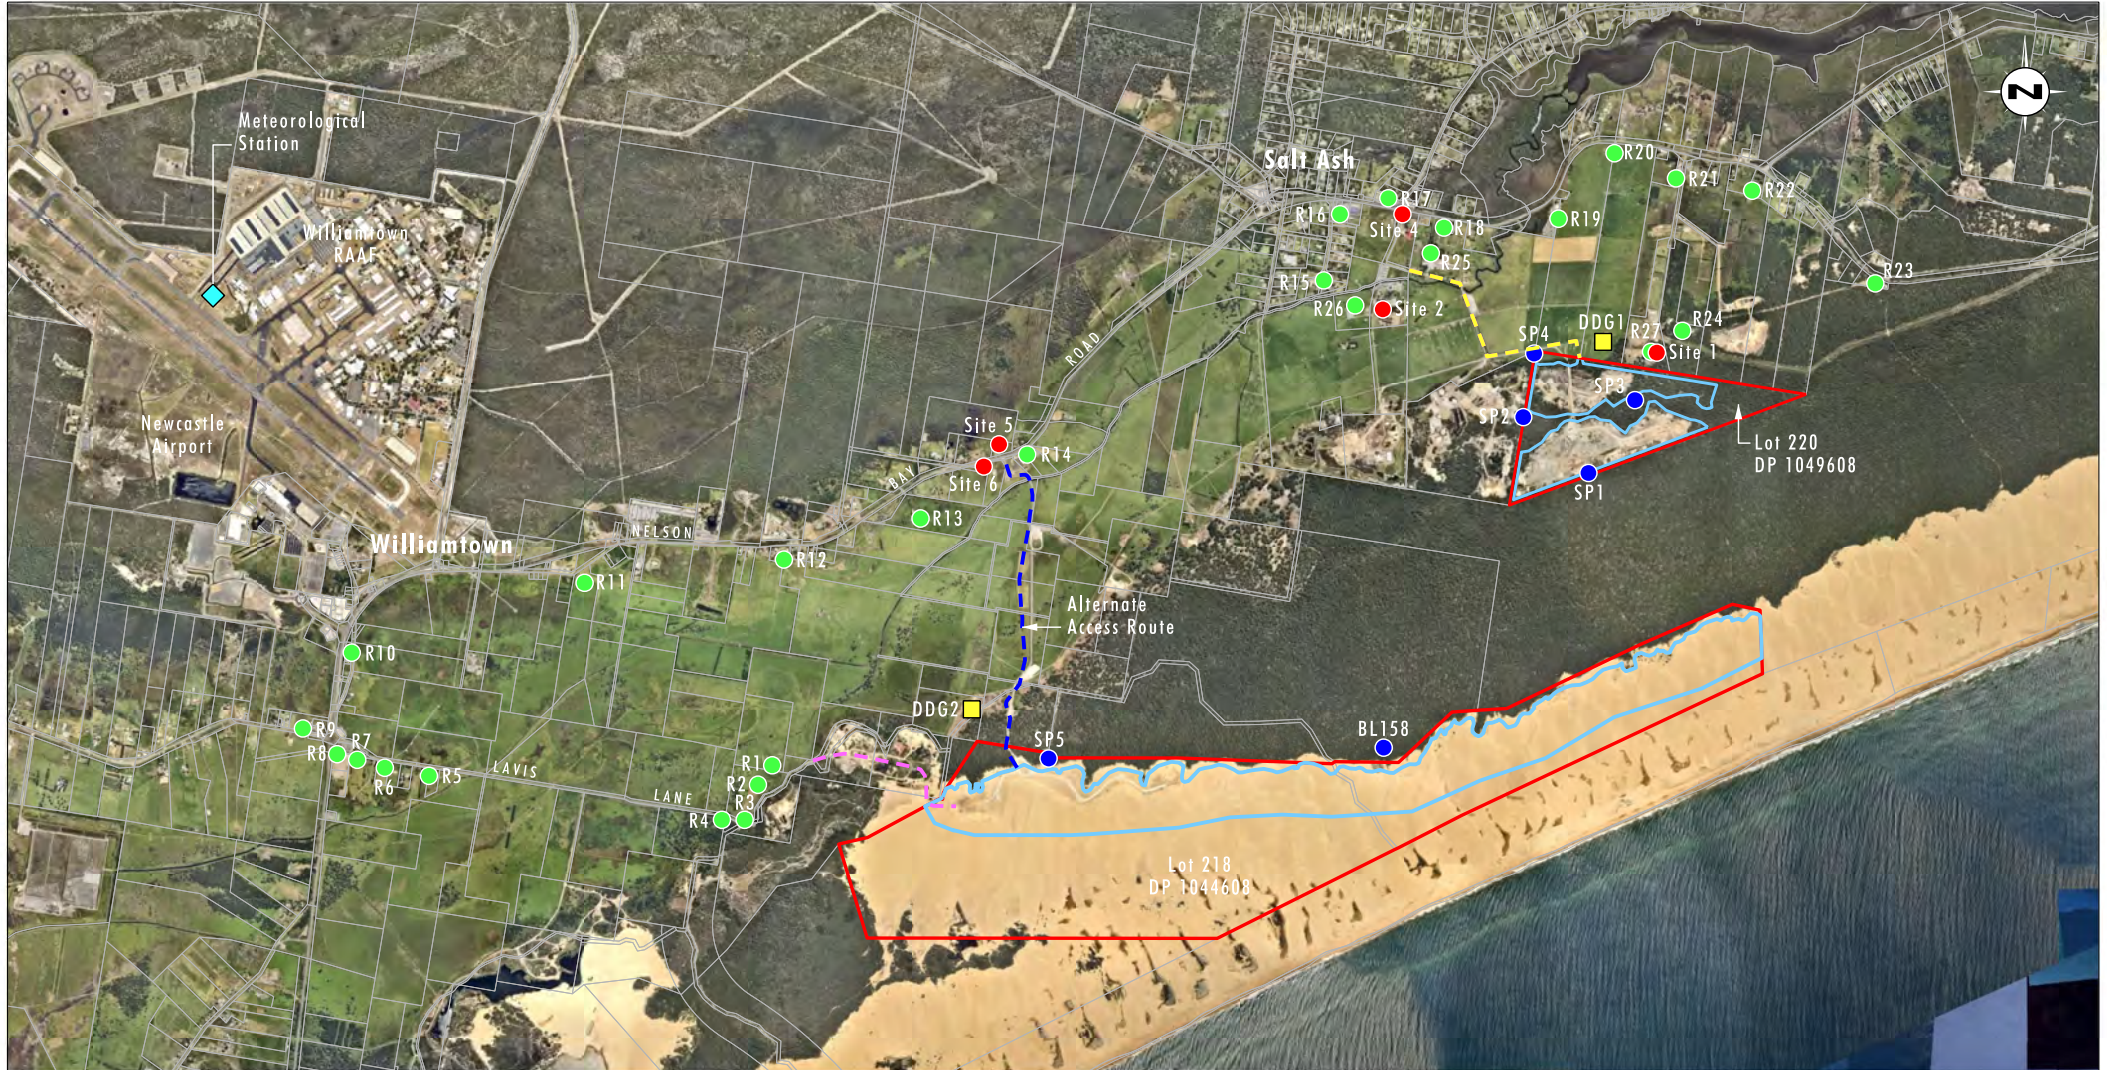
Figure 6-1 shows the Mackas Sand environmental monitoring locations.

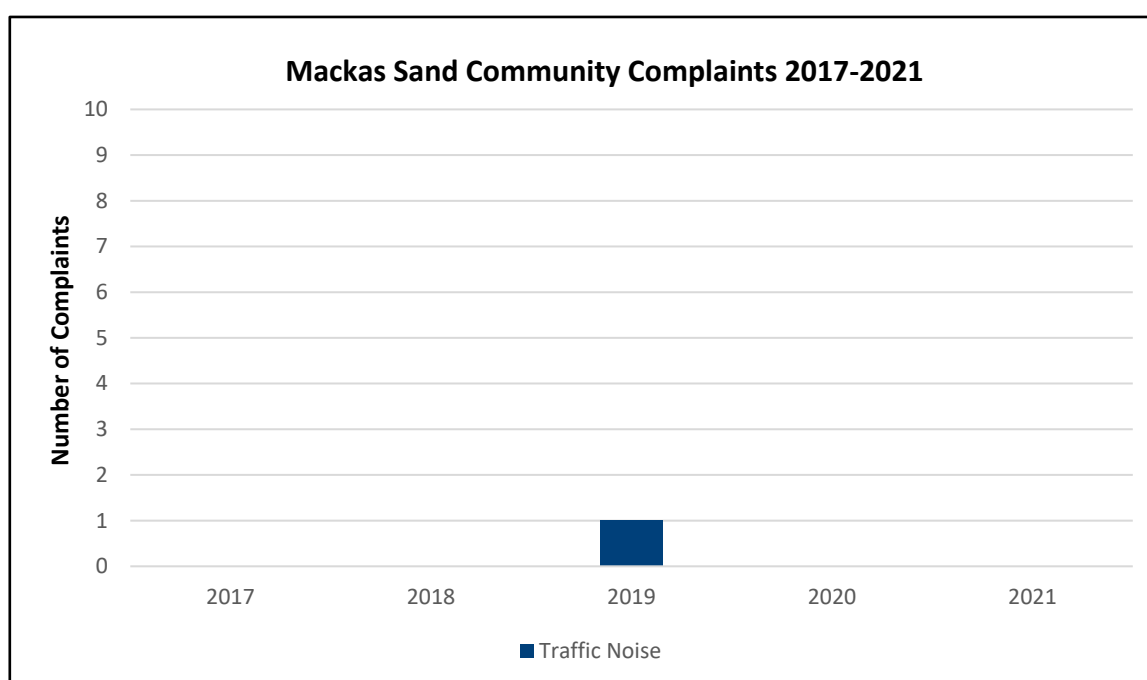
Figure 9-1 Summary of Mackas Sand Community Complaints from 2016-2021

A summary of community complaints received for the last five reporting periods is displayed in **Figure 9.1**. It is noted that 1 community complaint has been received between 2017-2021.
