## **MACKA'S SAND ANNUAL REVIEW JANUARY 2017 – DECEMBER 2017**

### **FINAL**

Prepared by  
**Umwelt (Australia) Pty Limited**  
on behalf of  
**Mackas Sand Pty Ltd**

Project Director: Bret Jenkins  
Project Manager: Brendan Rice  
Report No. 1646/R77/Final  
Date: March 2018

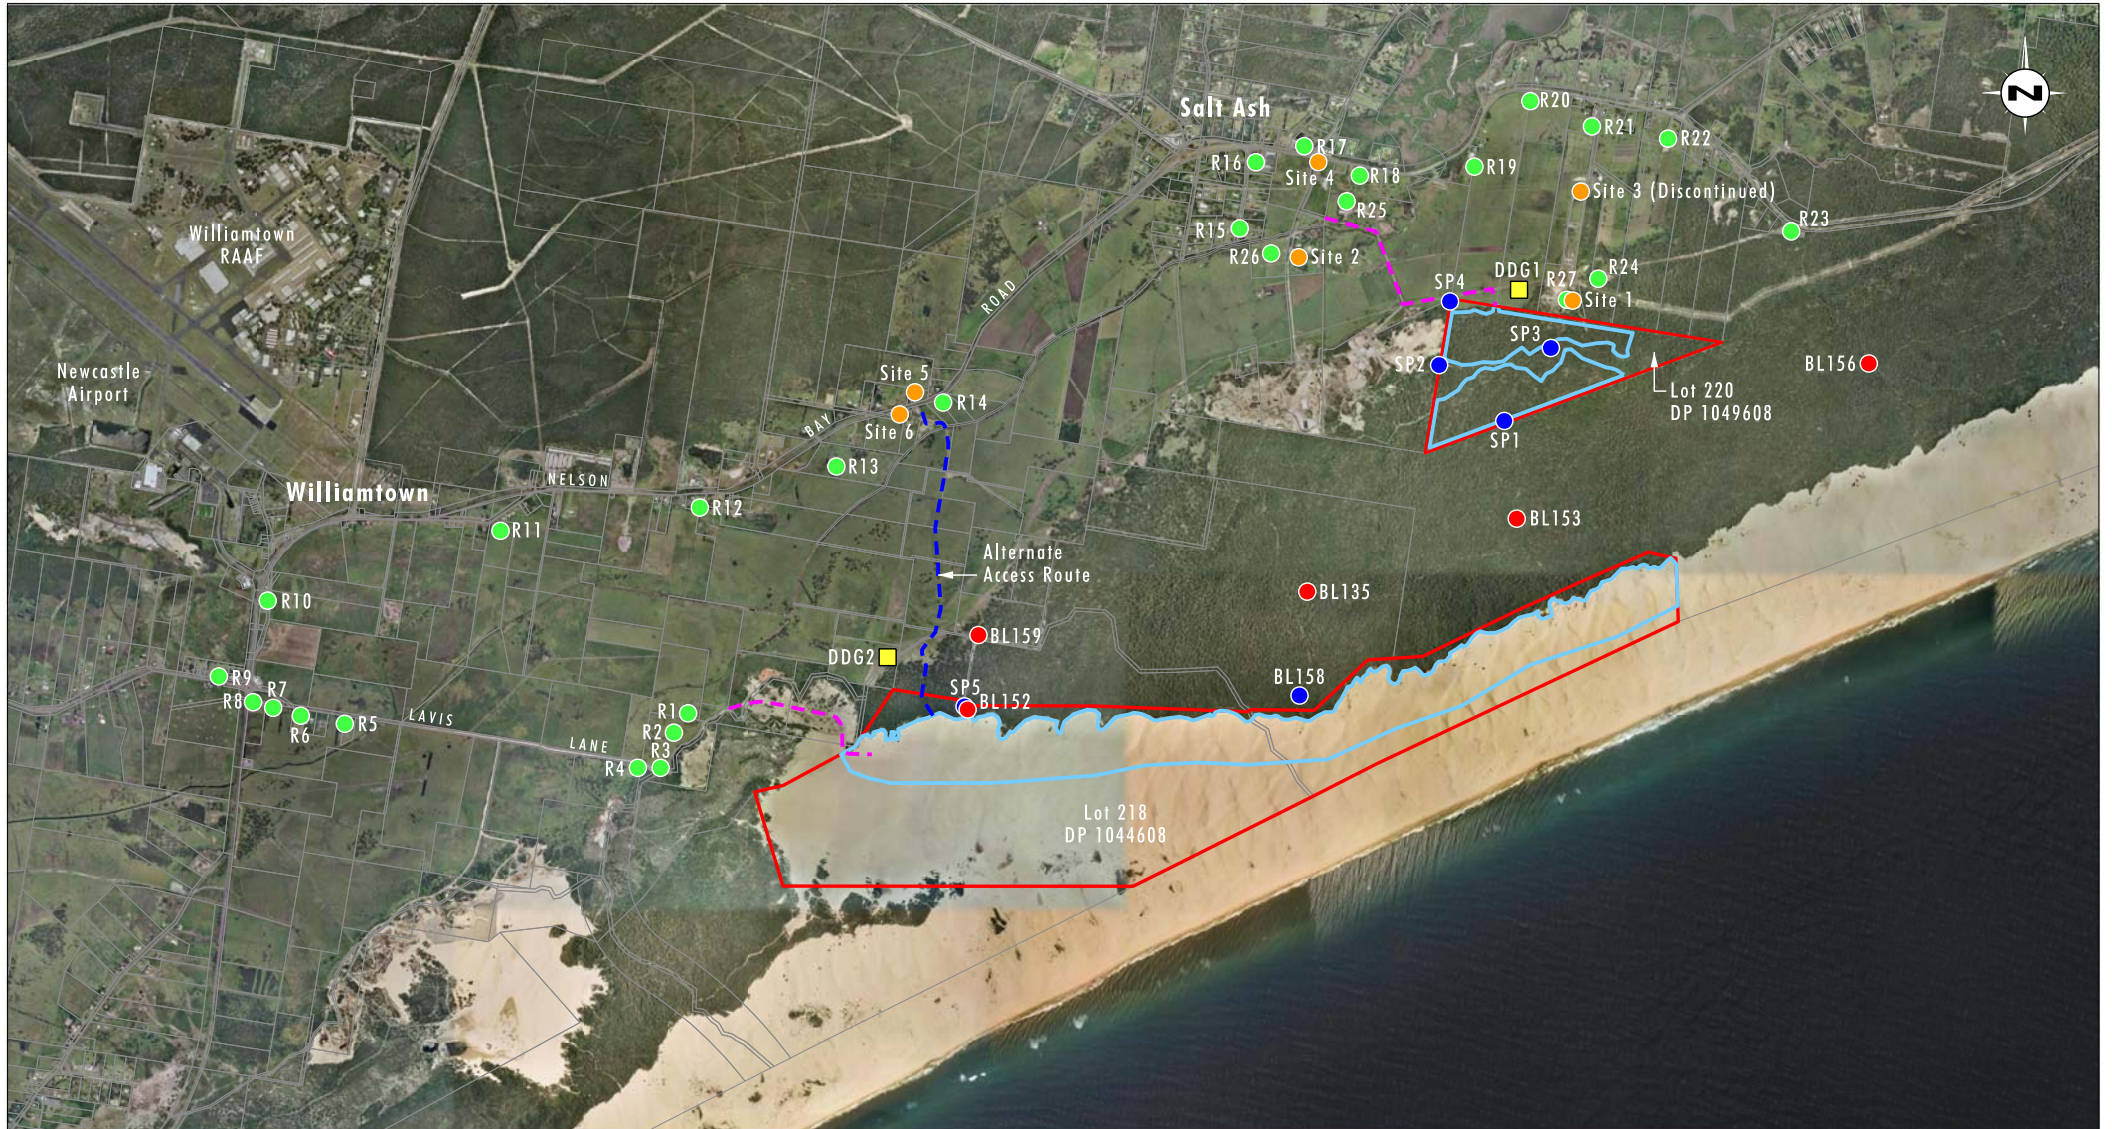
Condition 11 of Schedule 3 of Project Approval 08\_0142 (MOD 2) sets out air quality impact criteria for Macka's Sand. These criteria are used to assess the potential impacts of operations at nearby residential receivers. Criteria which apply to operations are specified in **Tables 6.11, 6.12 and 6.13** below. Dust monitoring locations are identified in **Figure 6.1**.

Groundwater monitoring was undertaken on a quarterly basis during the report period in accordance with Condition M2 of the EPL 13218. Bore locations are shown in **Figure 6.1**. Groundwater level measurements are shown in **Appendix 2**. Note that the report period is highlighted in blue within all tables and charts.

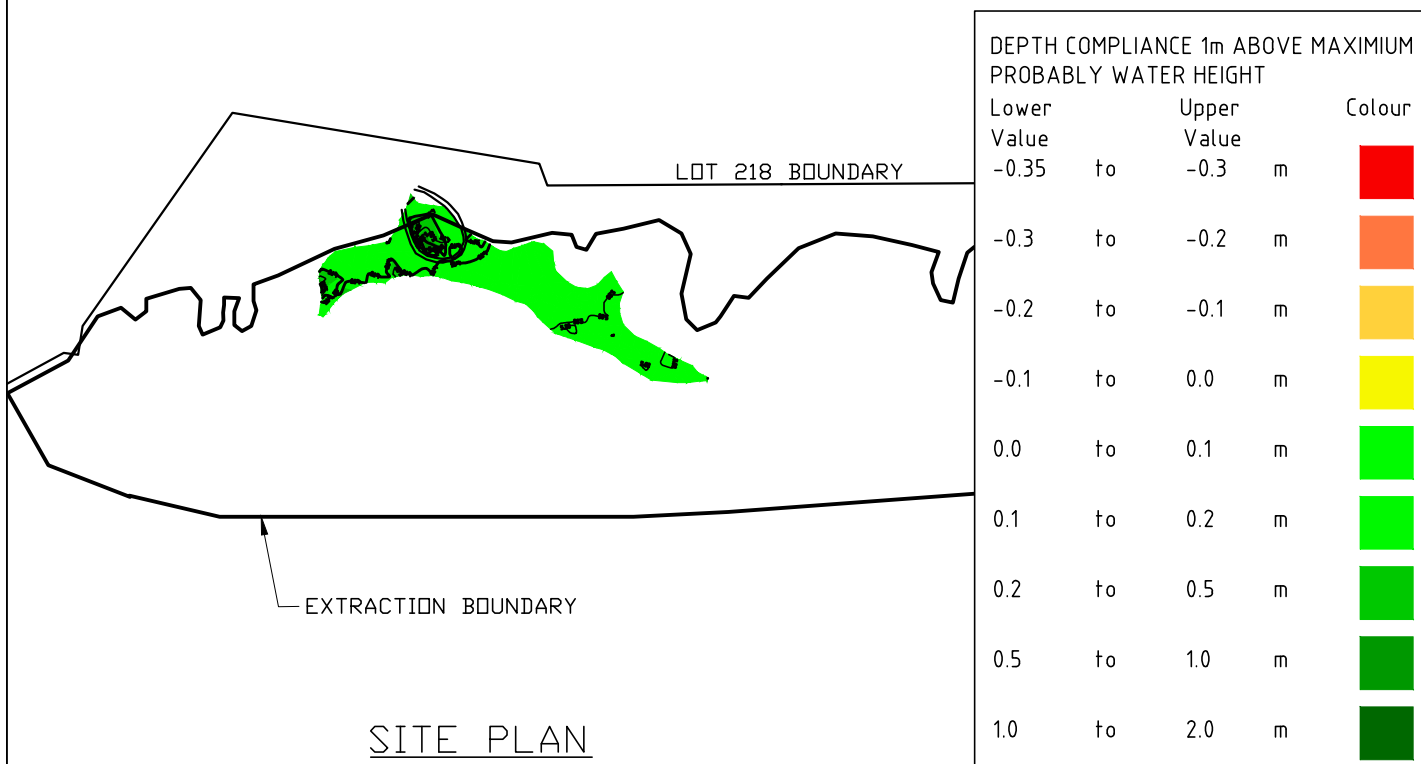
## CURRENT EXTRACTION FLOOR LEVELS 04/08/2017

SITE: <b>LOT 218 DP 1044608</b>	<b>1</b> DRAWING NO.		<b>0014</b> PROJECT NO.	<b>04/08/2017</b> DATE.
TITLE: <b>CURRENT EXTRACTION LEVELS</b>	<b>NOT TO SCALE</b> SCALE AT A4.	<b>CEJ</b> DRAWN.	<b>MH</b> CHECKED.	<b>A</b> REVISION.

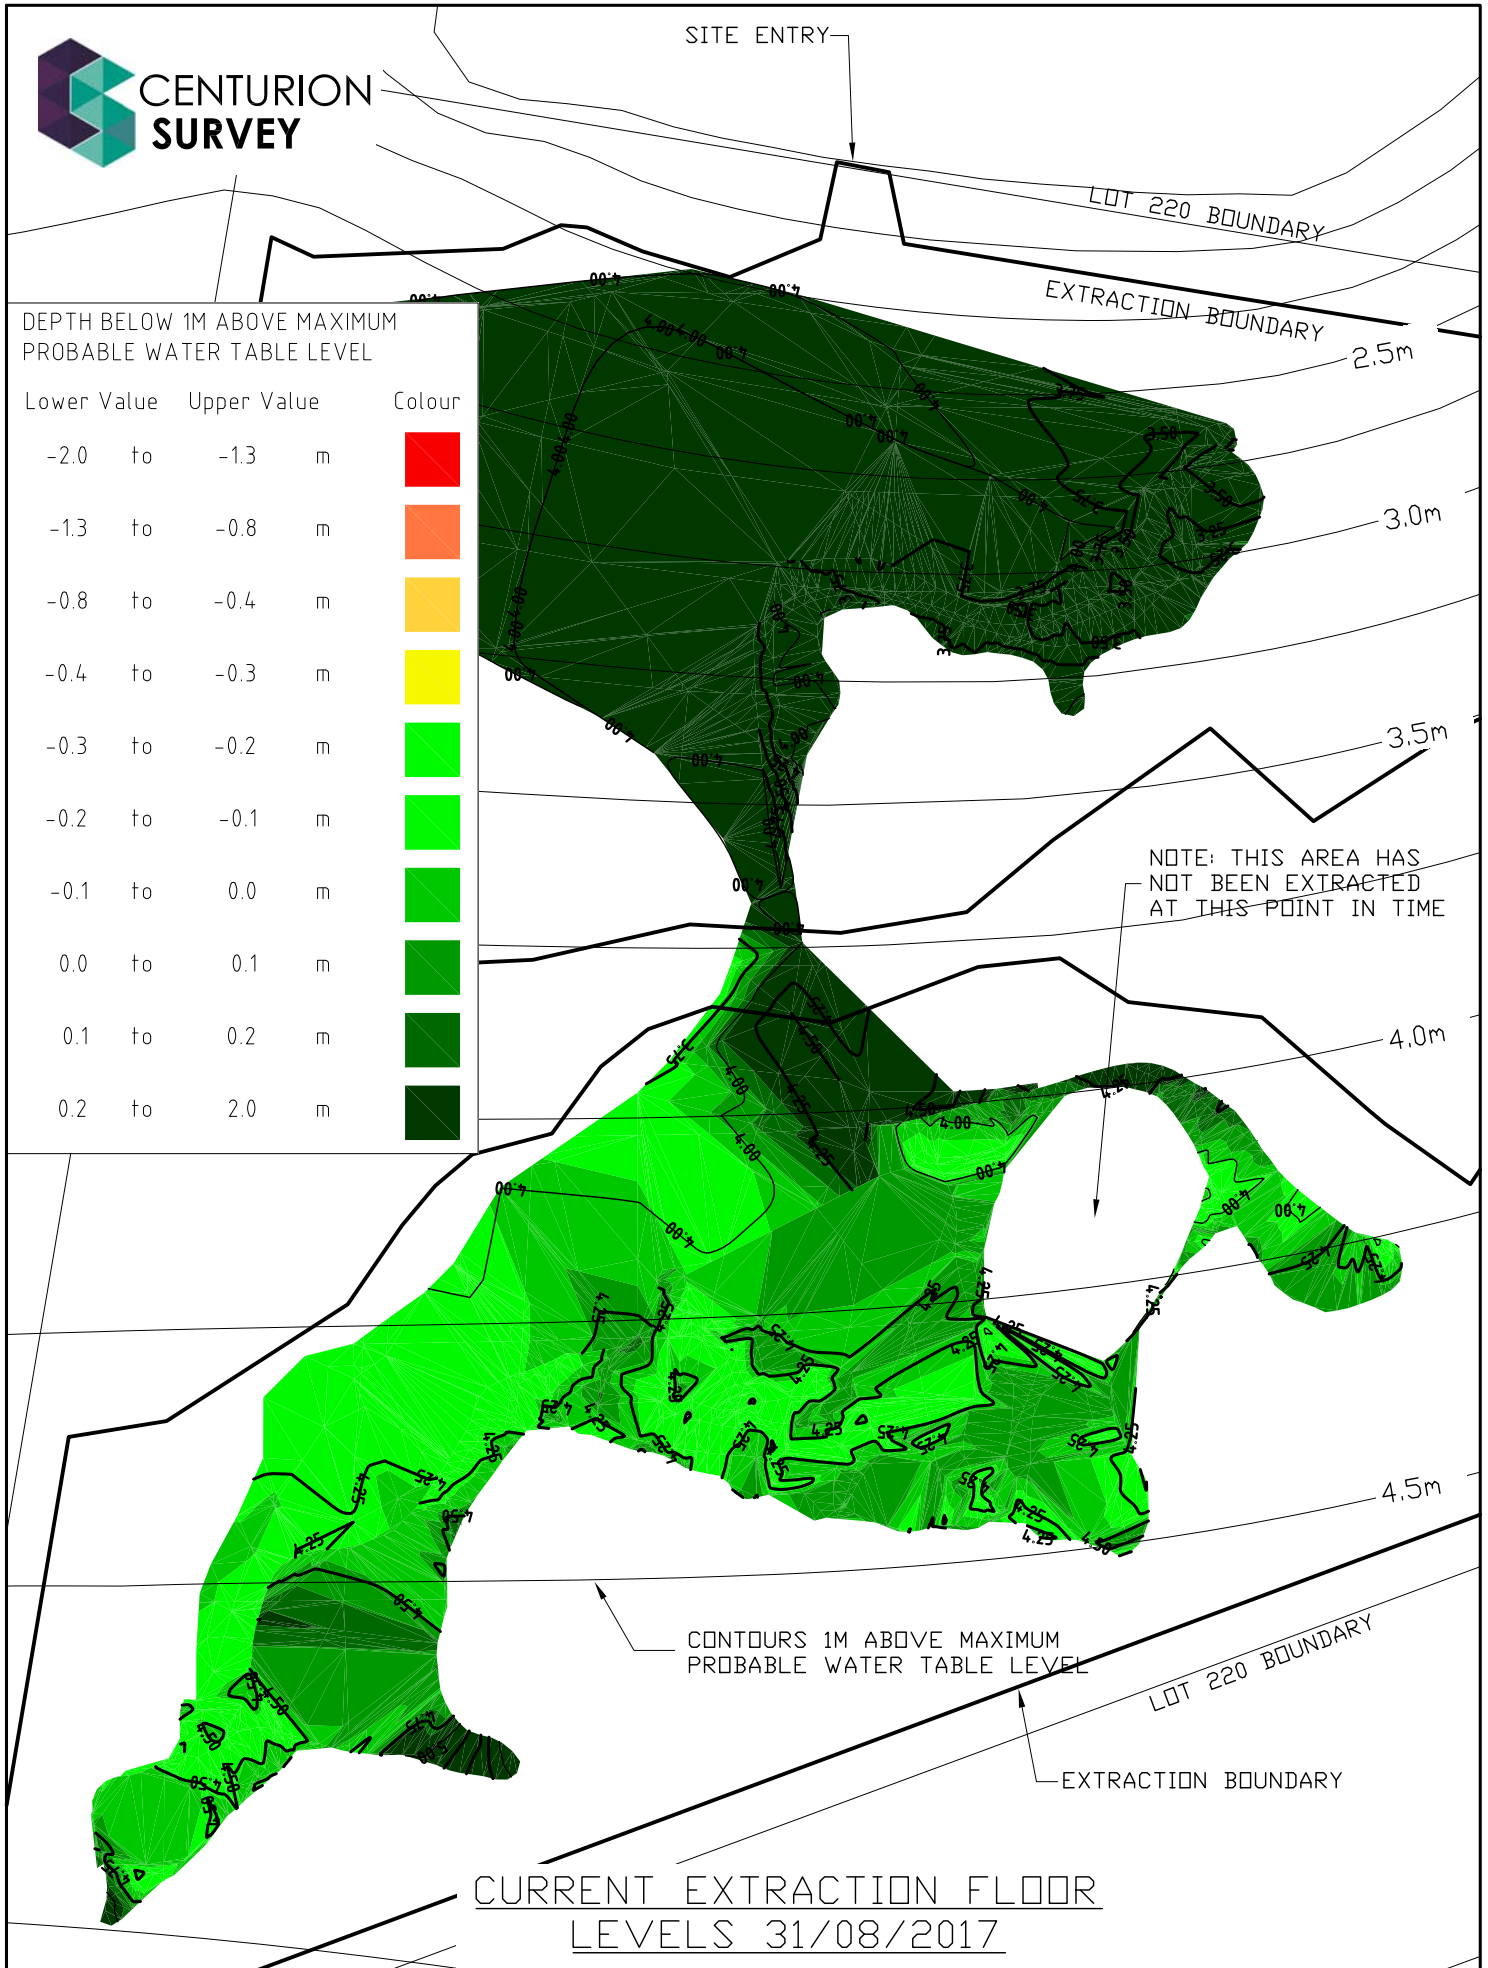
SITE:	LOT 220 DP 1049608	1 DRAWING NO.		0014 PROJECT NO.	31/08/2017 DATE.
TITLE:	CURRENT EXTRACTION LEVELS	NOT TO SCALE SCALE AT A4.	CEJ DRAWN.	MH CHECKED.	A REVISION.

DEPTH BELOW 1M ABOVE MAXIMUM PROBABLE WATER TABLE LEVEL				Colour
Lower Value	to	Upper Value		
-2.0	to	-1.3	m	 
-1.3	to	-0.8	m	 
-0.8	to	-0.4	m	 
-0.4	to	-0.3	m	 
-0.3	to	-0.2	m	 
-0.2	to	-0.1	m	 
-0.1	to	0.0	m	 
0.0	to	0.1	m	 
0.1	to	0.2	m	 
0.2	to	2.0	m

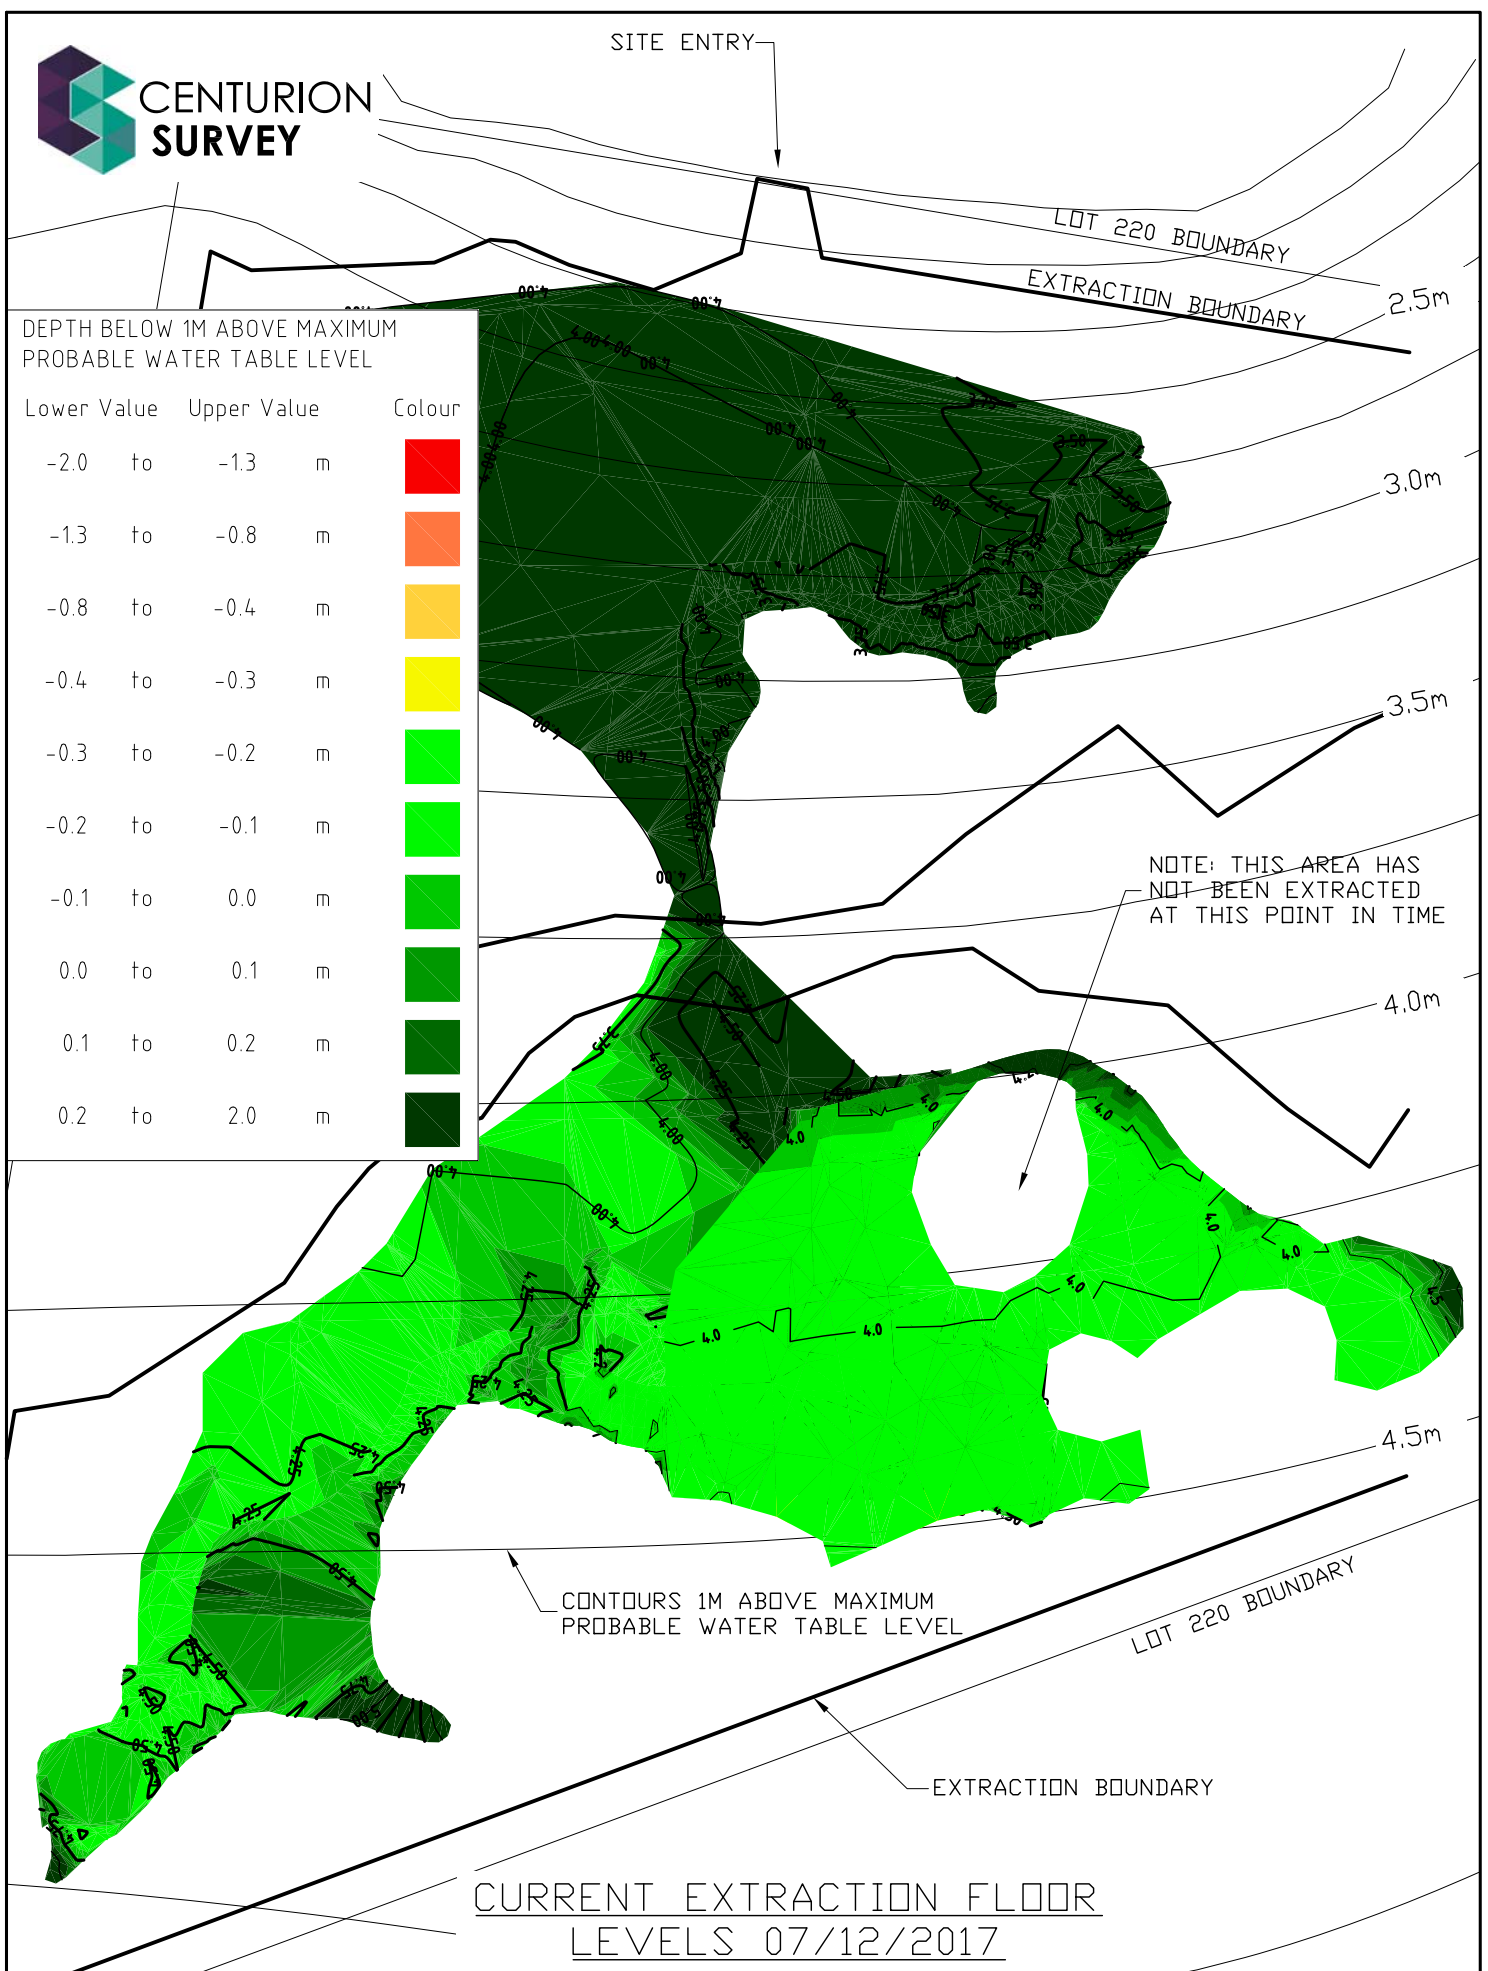
SITE: <b>LOT 220 DP 1049608</b>		<b>220DEC2017</b> DRAWING NO.		<b>0014</b> PROJECT NO.	<b>07/12/2017</b> DATE.
TITLE: <b>CURRENT EXTRACTION LEVELS</b>		<b>NOT TO SCALE</b> SCALE AT A4.	<b>CEJ</b> DRAWN.	<b>MH</b> CHECKED.	<b>A</b> REVISION.

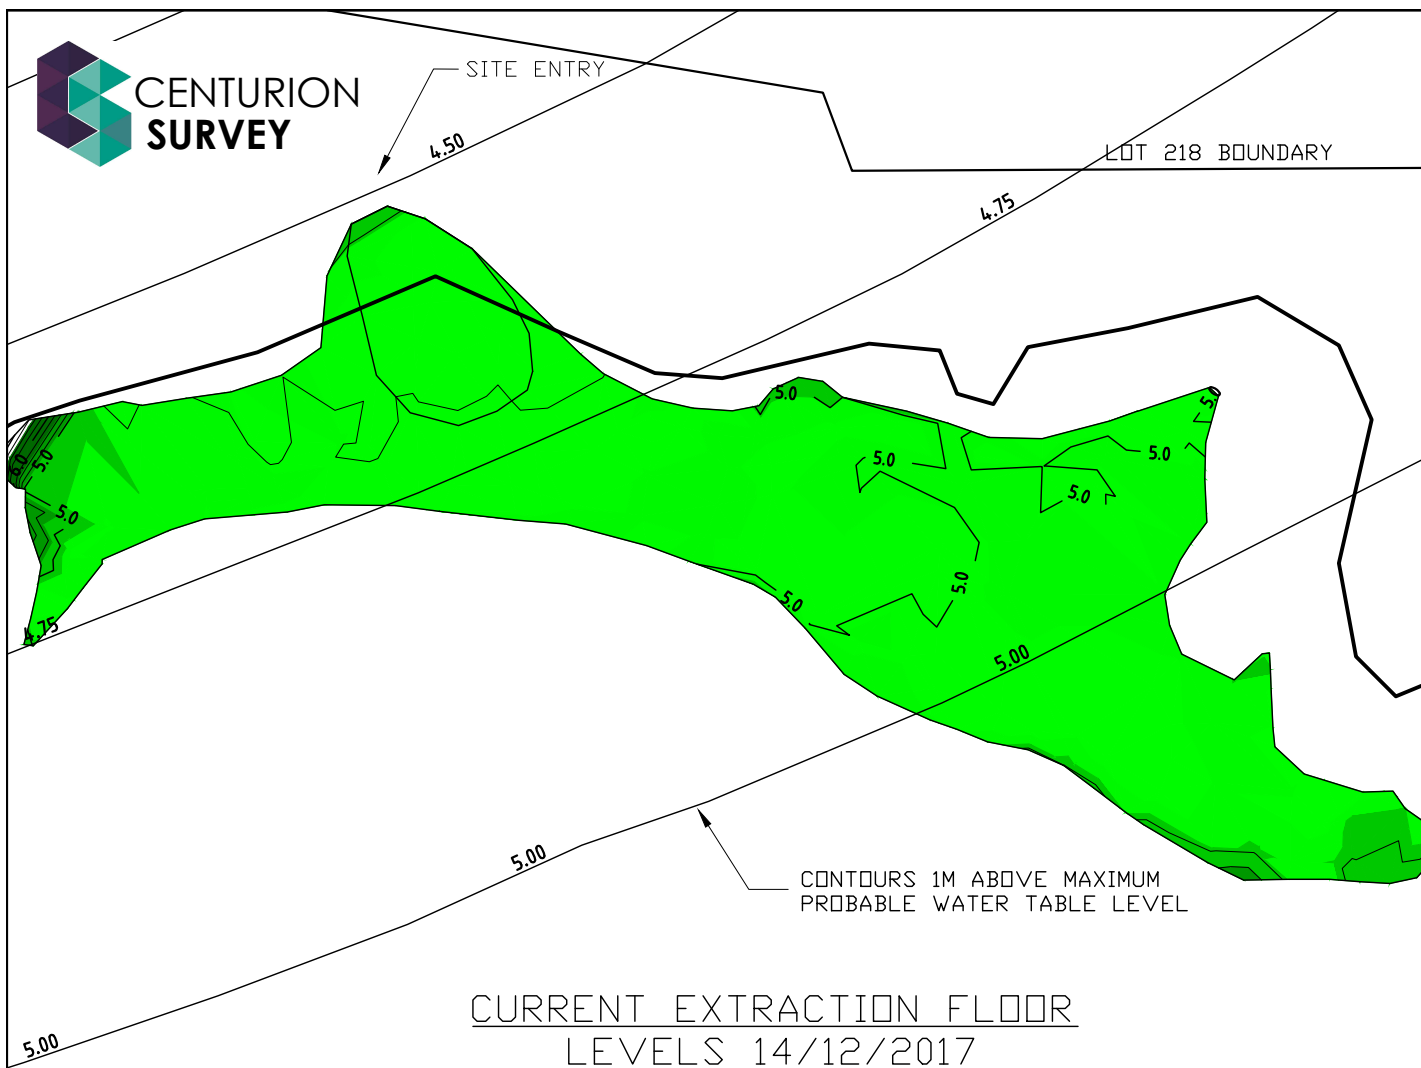
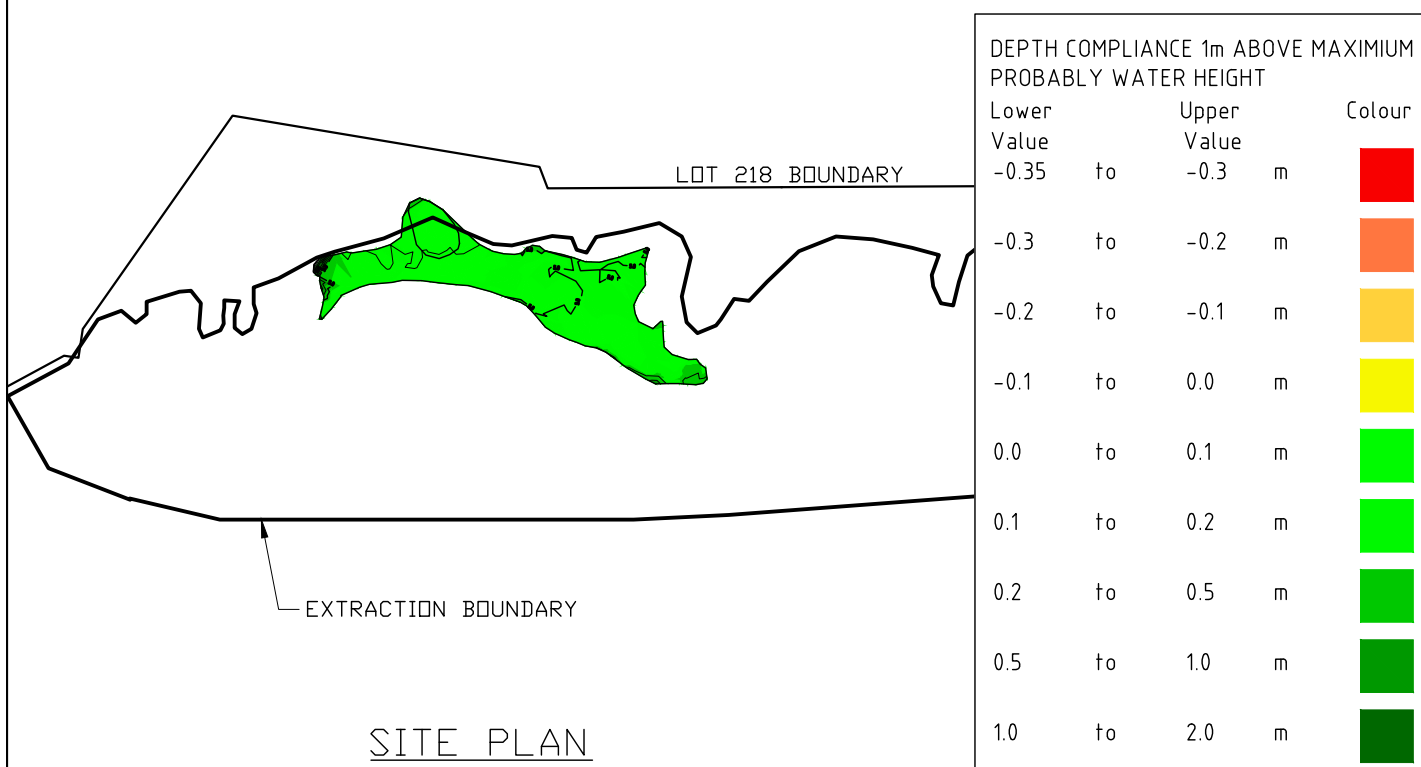
SITE: <b>LOT 218 DP 1044608</b>	<b>218DEC2017</b> DRAWING NO.	<b>0014</b> PROJECT NO.	<b>14/12/2017</b> DATE.
TITLE: <b>CURRENT EXTRACTION LEVELS</b>	<b>NOT TO SCALE</b> SCALE AT A4.	<b>CEJ</b> DRAWN.	<b>MH</b> CHECKED. <b>A</b> REVISION.
