MACKAS SAND ANNUAL REVIEW 2019

January – December 2019

Prepared by
Umwelt (Australia) Pty Limited
on behalf of
Mackas Sand Pty Ltd

Project Director: **Bret Jenkins**
Project Manager: **Rod Williams**
Report No. **1646/R95**
Date: **March 2020**

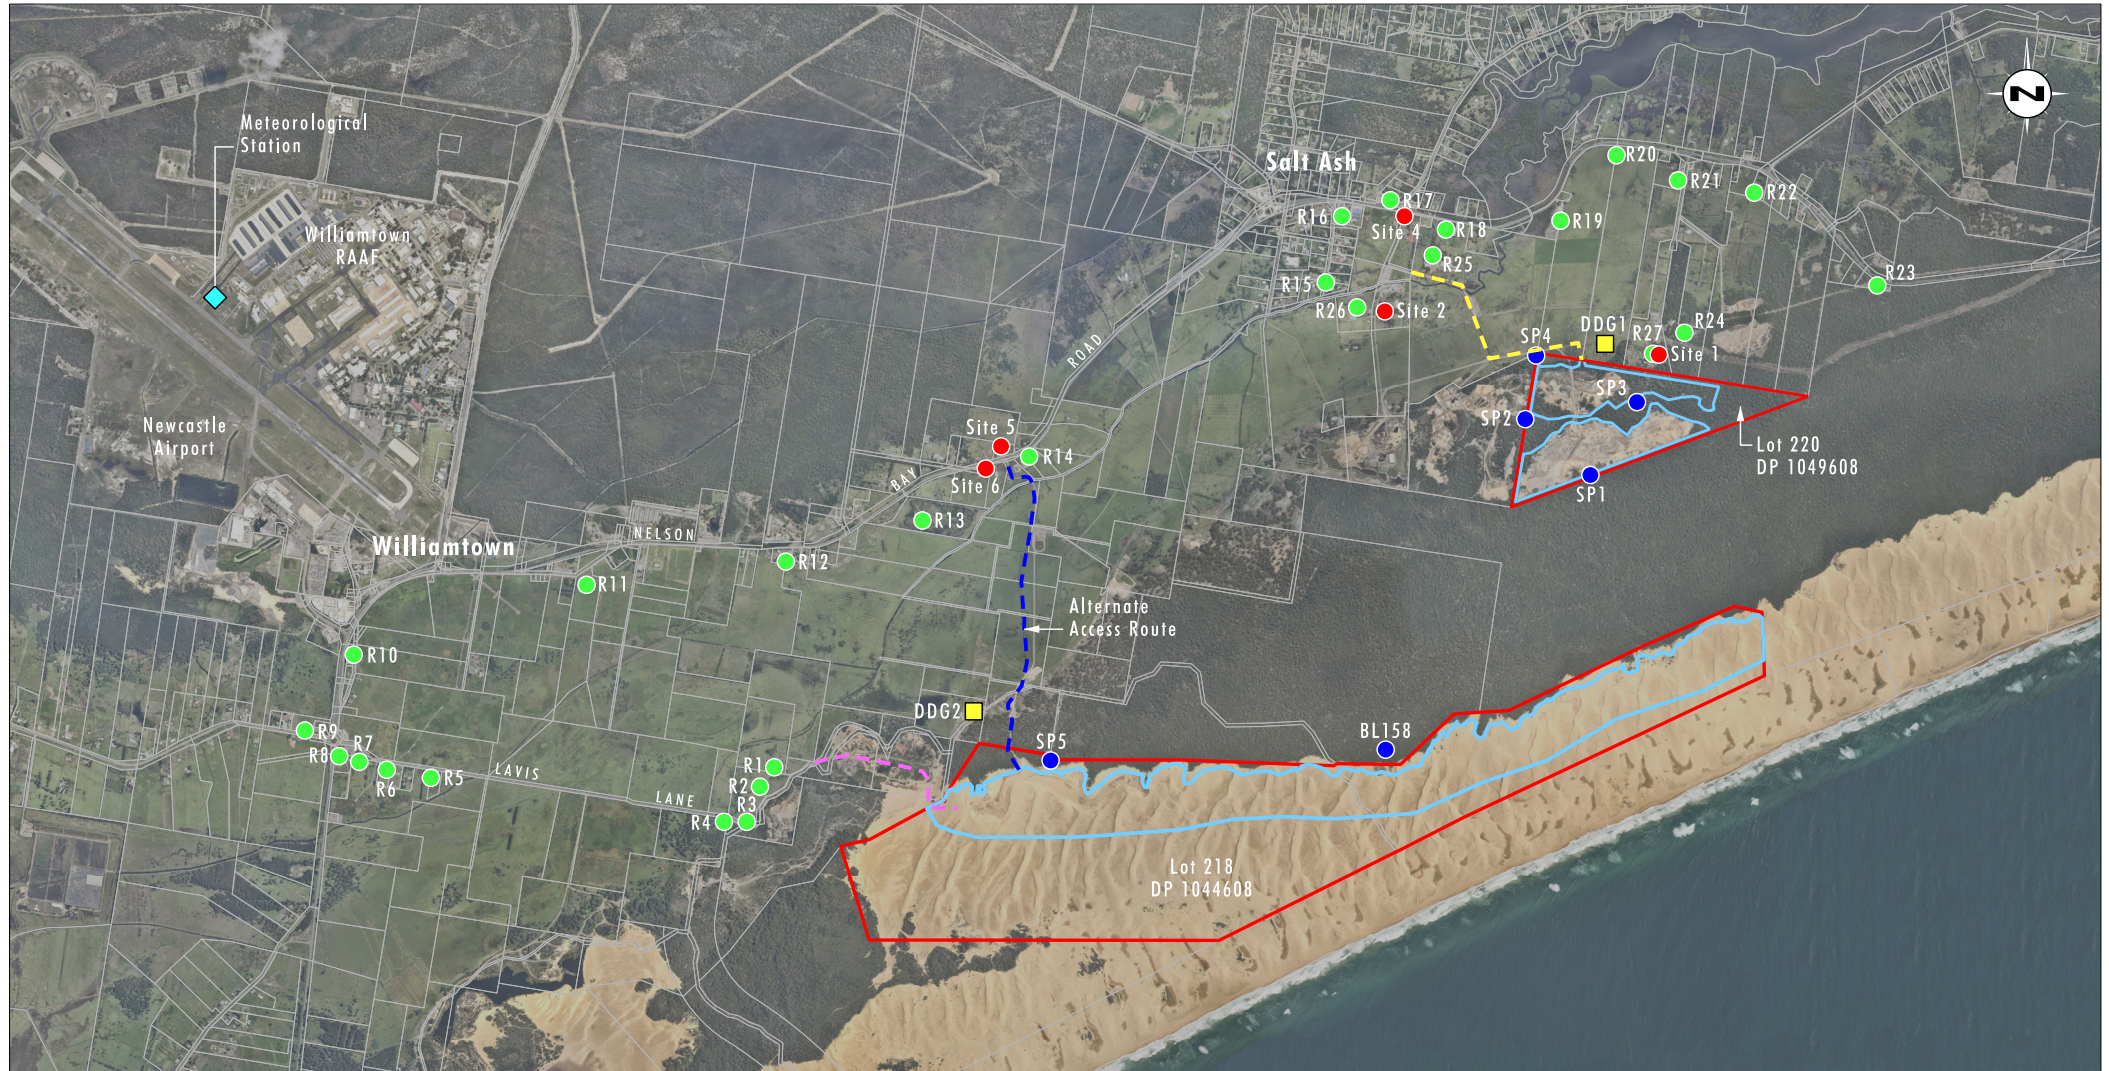
Figure 6.1 shows the Mackas Sand environmental monitoring locations.

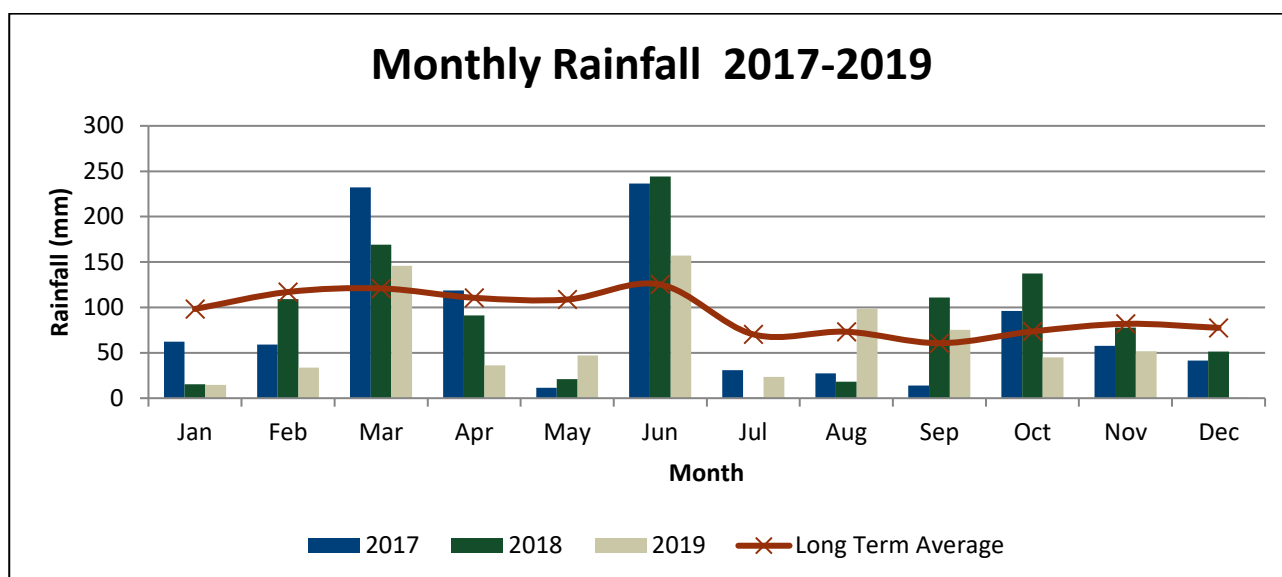
Figure 6.2 Monthly Rainfall 2017-2019

The wider Hunter region has experienced ongoing below average rainfall over the previous 24 months which has contributed to drought conditions across the state.

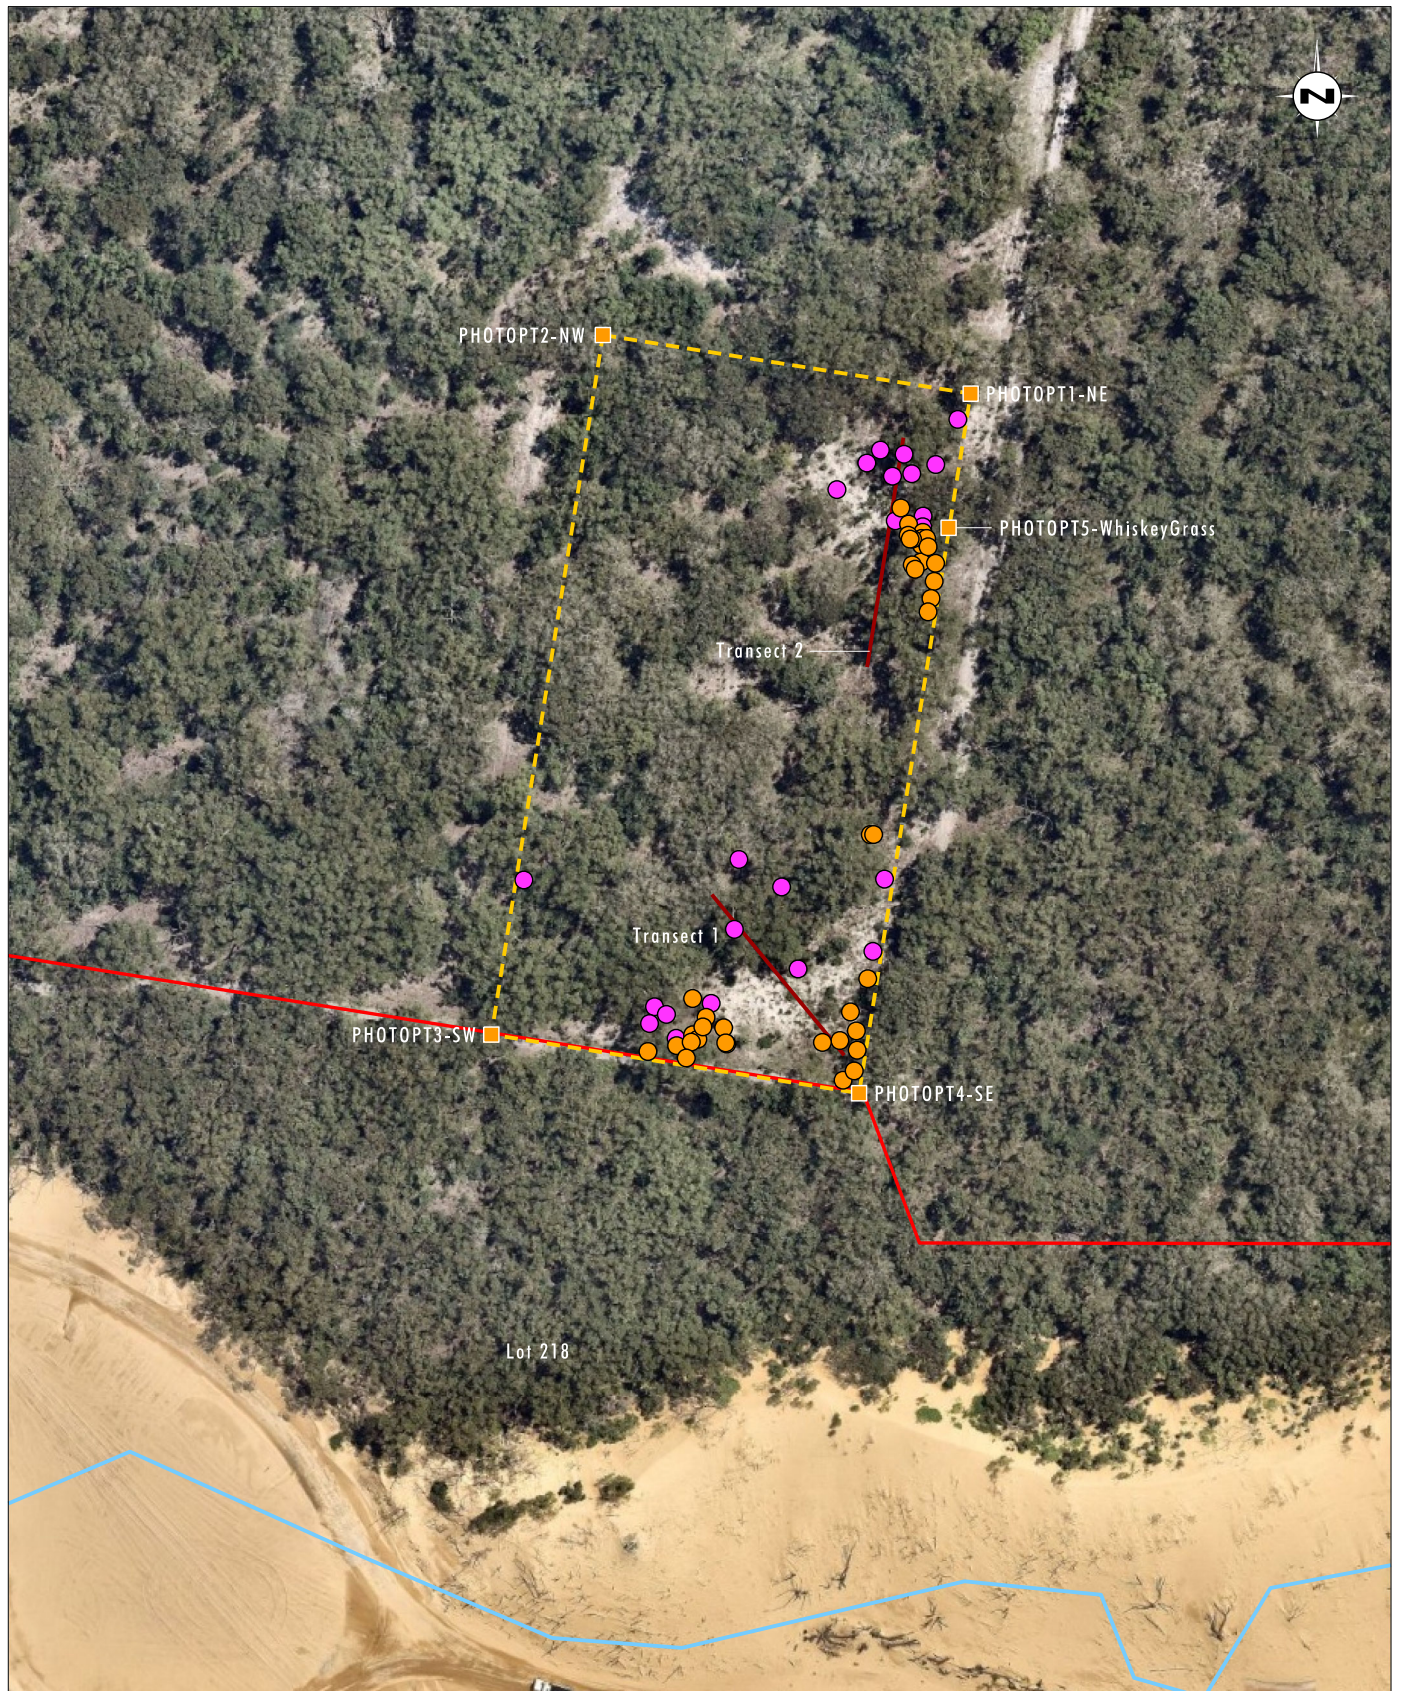
The Mackas Sand Biodiversity Offset Area, transect, photographic monitoring locations and the 2019 orchid locations is provided in **Figure 6.3**.

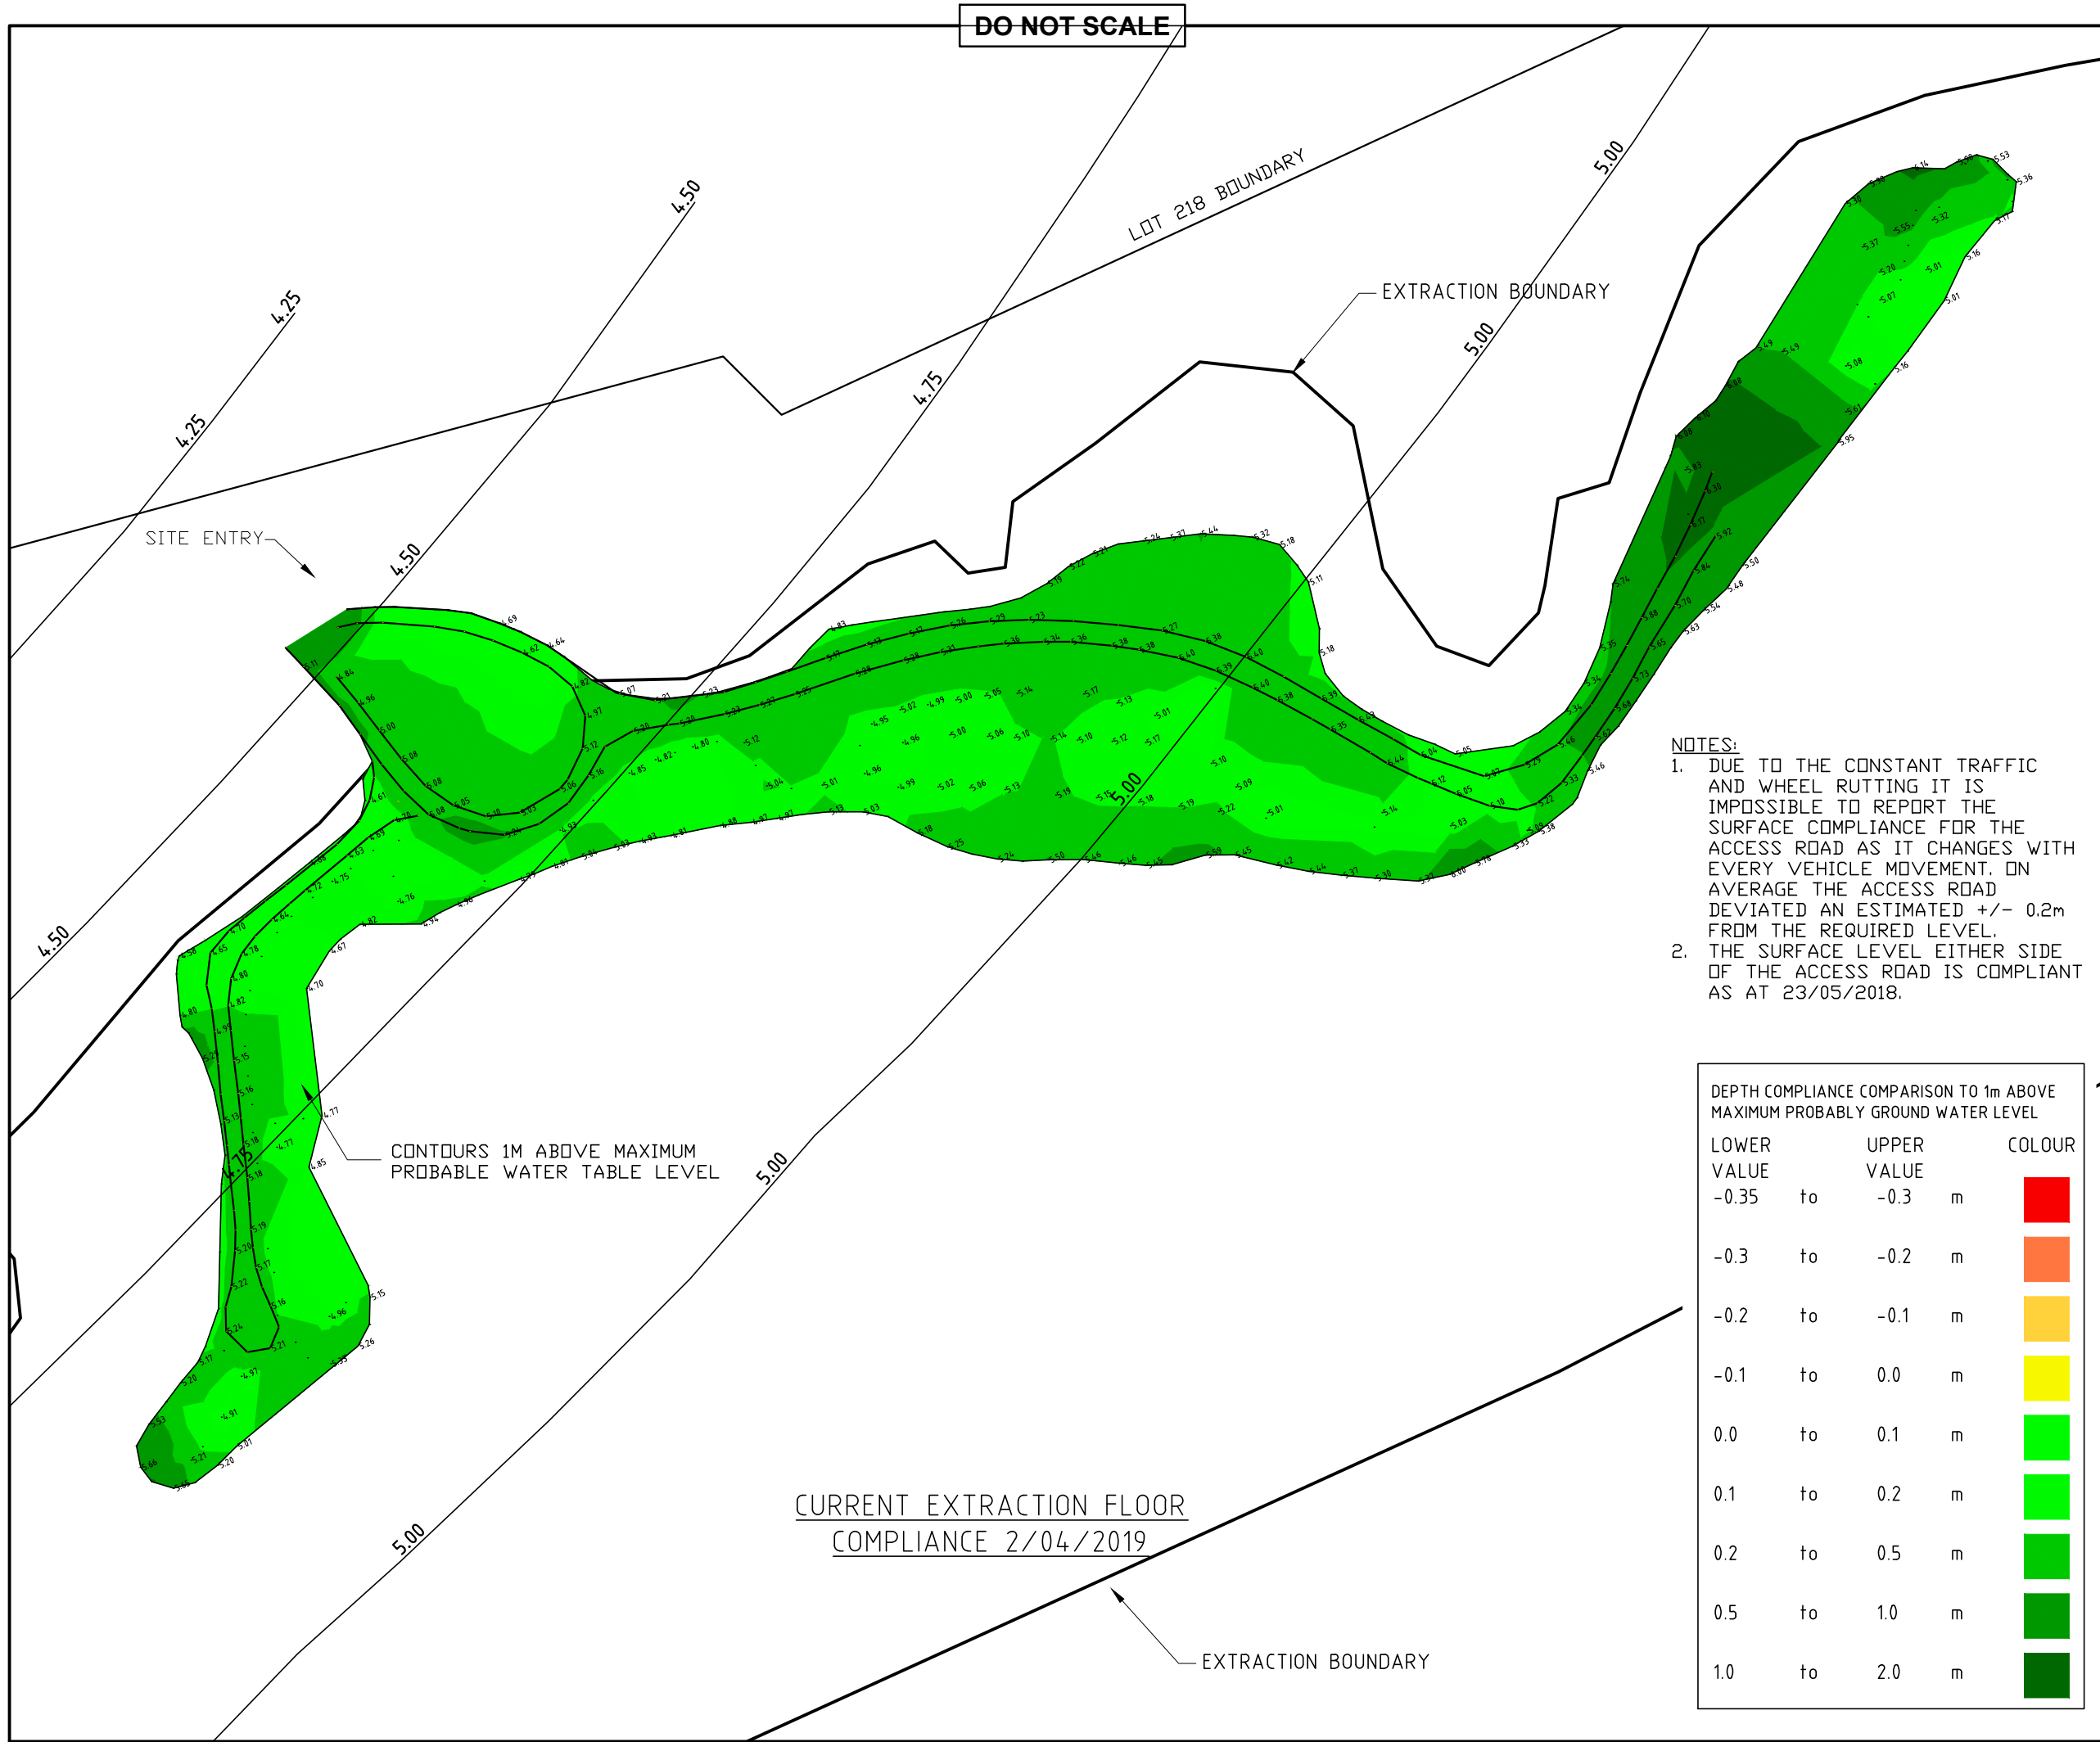
- NOTES:
1. DUE TO THE CONSTANT TRAFFIC AND WHEEL RUTTING IT IS IMPOSSIBLE TO REPORT THE SURFACE COMPLIANCE FOR THE ACCESS ROAD AS IT CHANGES WITH EVERY VEHICLE MOVEMENT. ON AVERAGE THE ACCESS ROAD DEVIATED AN ESTIMATED +/- 0.2m FROM THE REQUIRED LEVEL.
 2. THE SURFACE LEVEL EITHER SIDE OF THE ACCESS ROAD IS COMPLIANT AS AT 23/05/2018.

DEPTH COMPLIANCE COMPARISON TO 1m ABOVE MAXIMUM PROBABLE GROUND WATER LEVEL				COLOUR
LOWER VALUE		UPPER VALUE		
-0.35	to	-0.3	m	
-0.3	to	-0.2	m	
-0.2	to	-0.1	m	
-0.1	to	0.0	m	
0.0	to	0.1	m	
0.1	to	0.2	m	
0.2	to	0.5	m	
0.5	to	1.0	m	
1.0	to	2.0	m

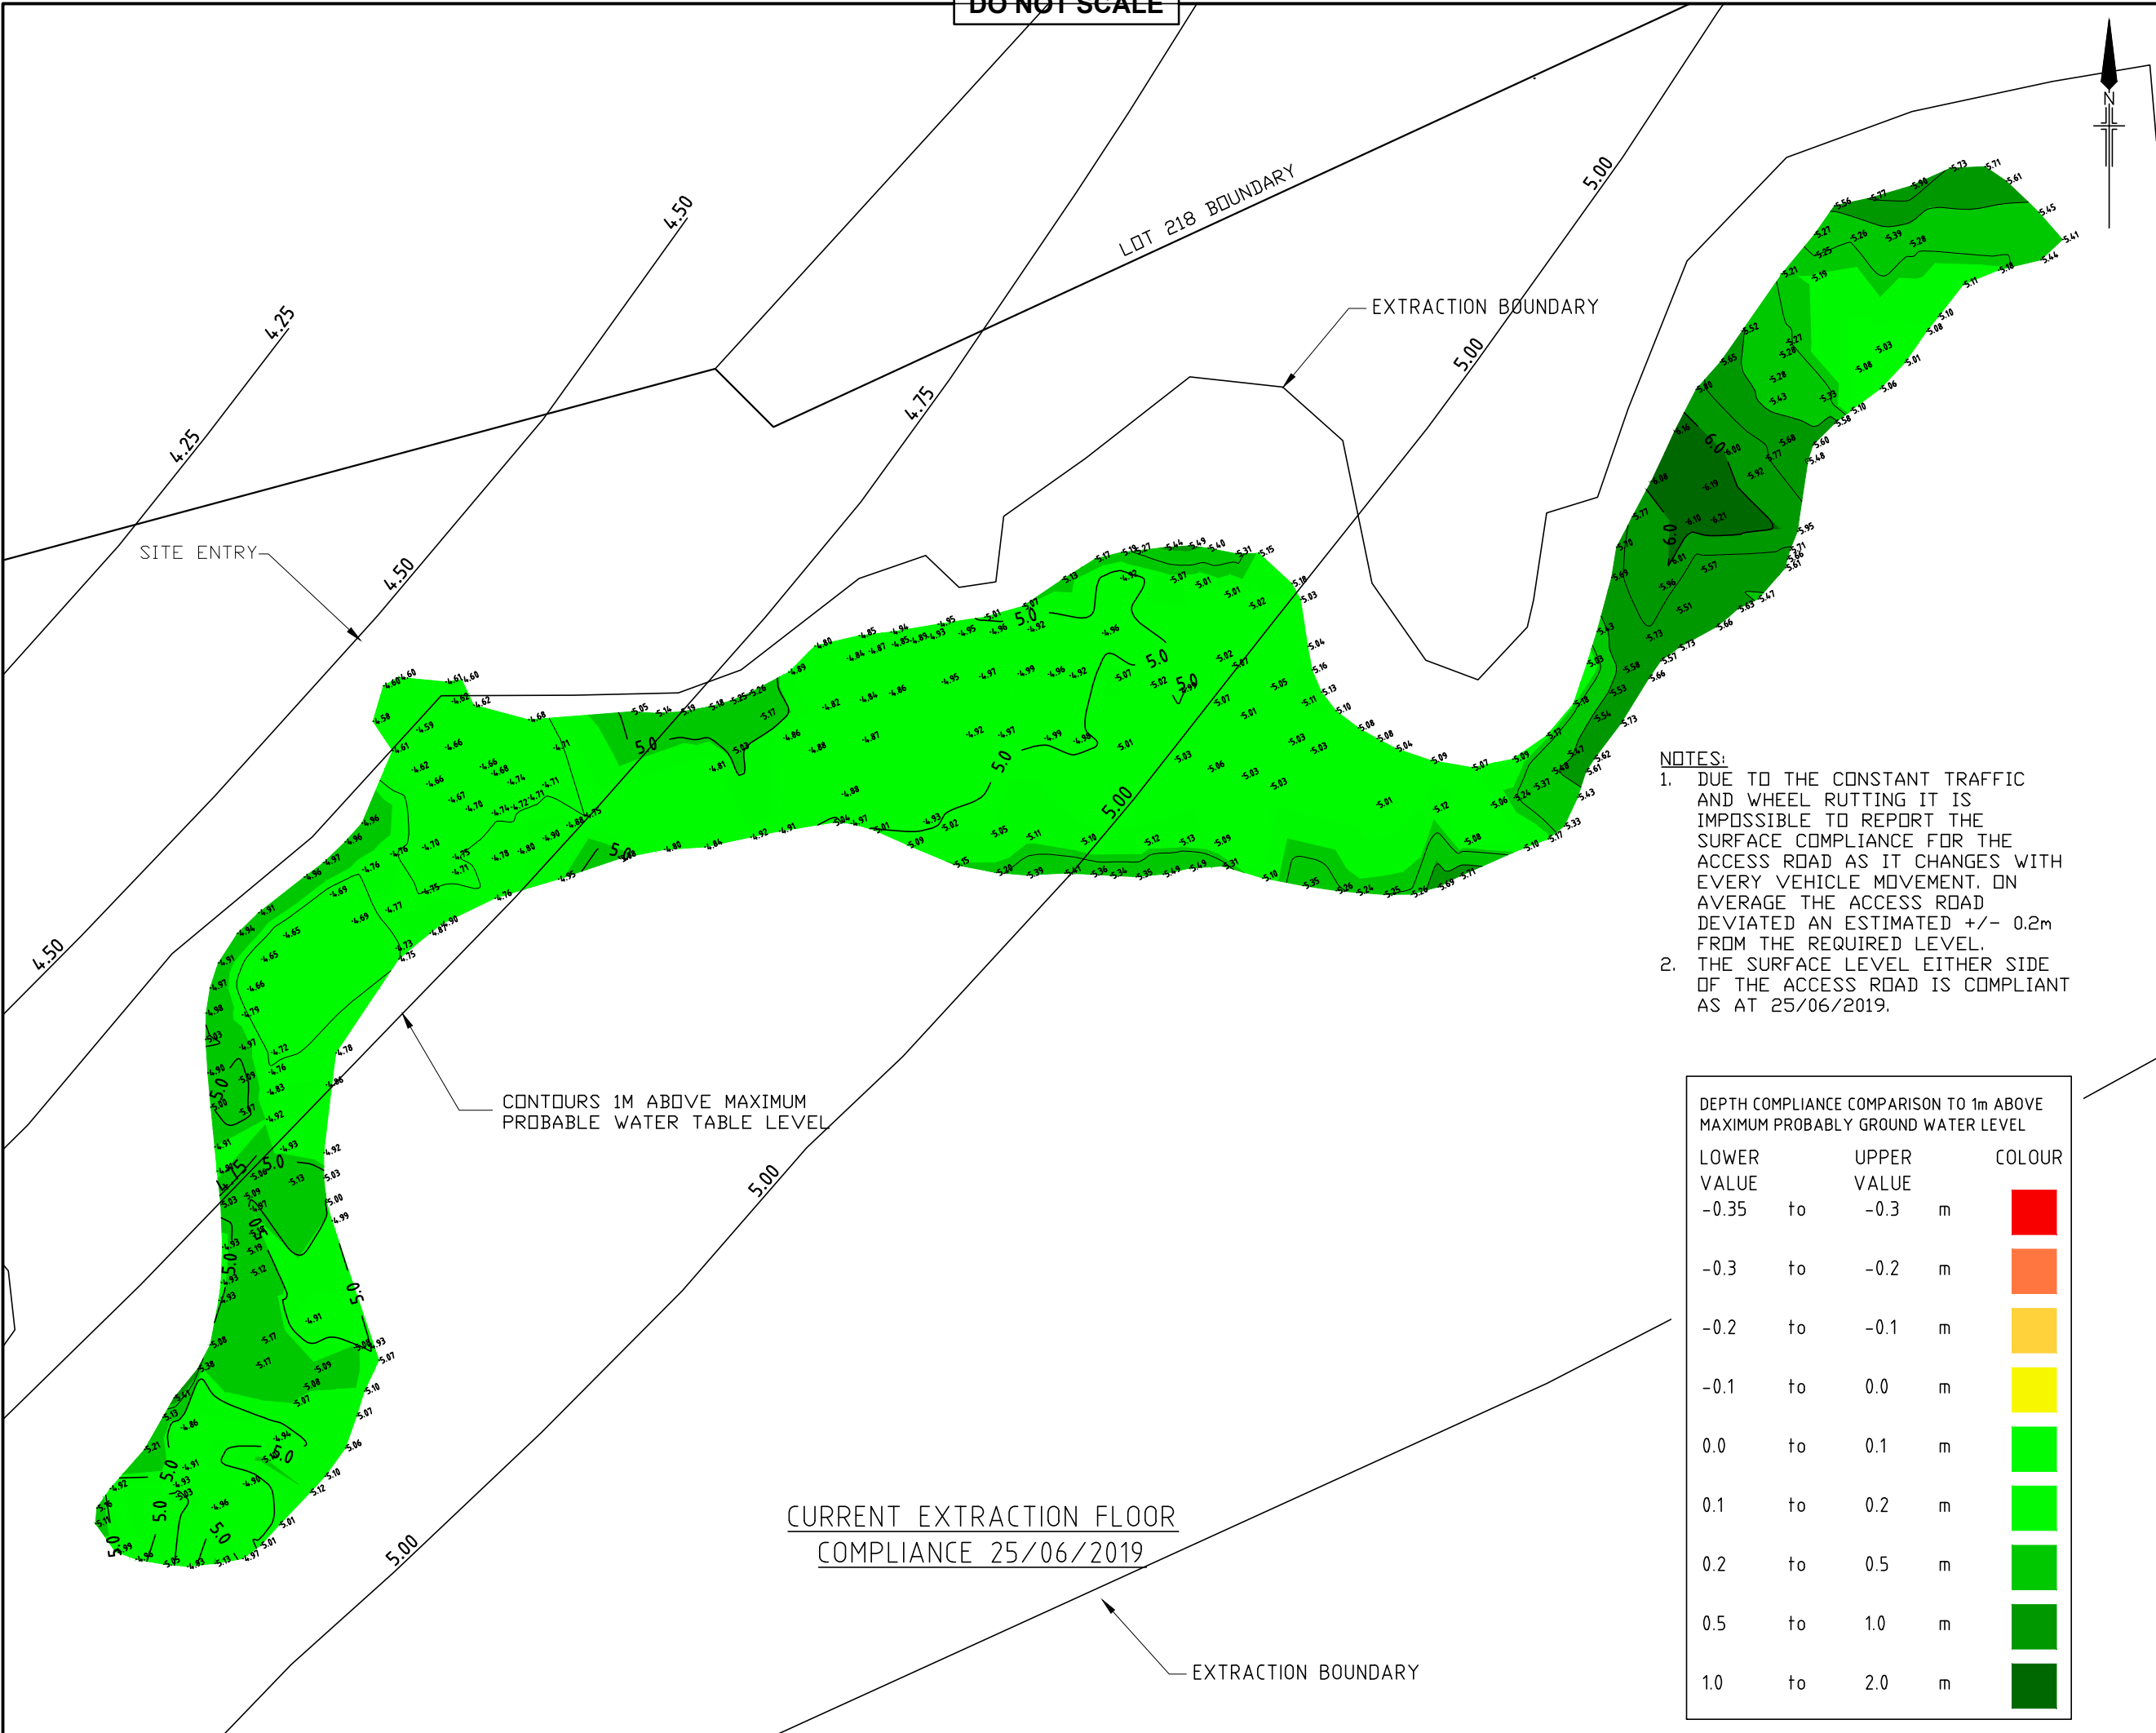
TITLE:	LOT 218 EXTRACTION LEVEL COMPLIANCE
STATUS:	JUNE 2019
DRAWING NUMBER:	
SHEET 1 OF 1 SHEETS

DEPTH COMPLIANCE COMPARISON TO 1m ABOVE MAXIMUM PROBABLE GROUND WATER LEVEL				
LOWER VALUE		UPPER VALUE		COLOUR
-0.35	to	-0.3	m	 
-0.3	to	-0.2	m	 
-0.2	to	-0.1	m	 
-0.1	to	0.0	m	 
0.0	to	0.1	m	 
0.1	to	0.2	m	 
0.2	to	0.5	m	 
0.5	to	1.0	m	 
1.0	to	2.0	m

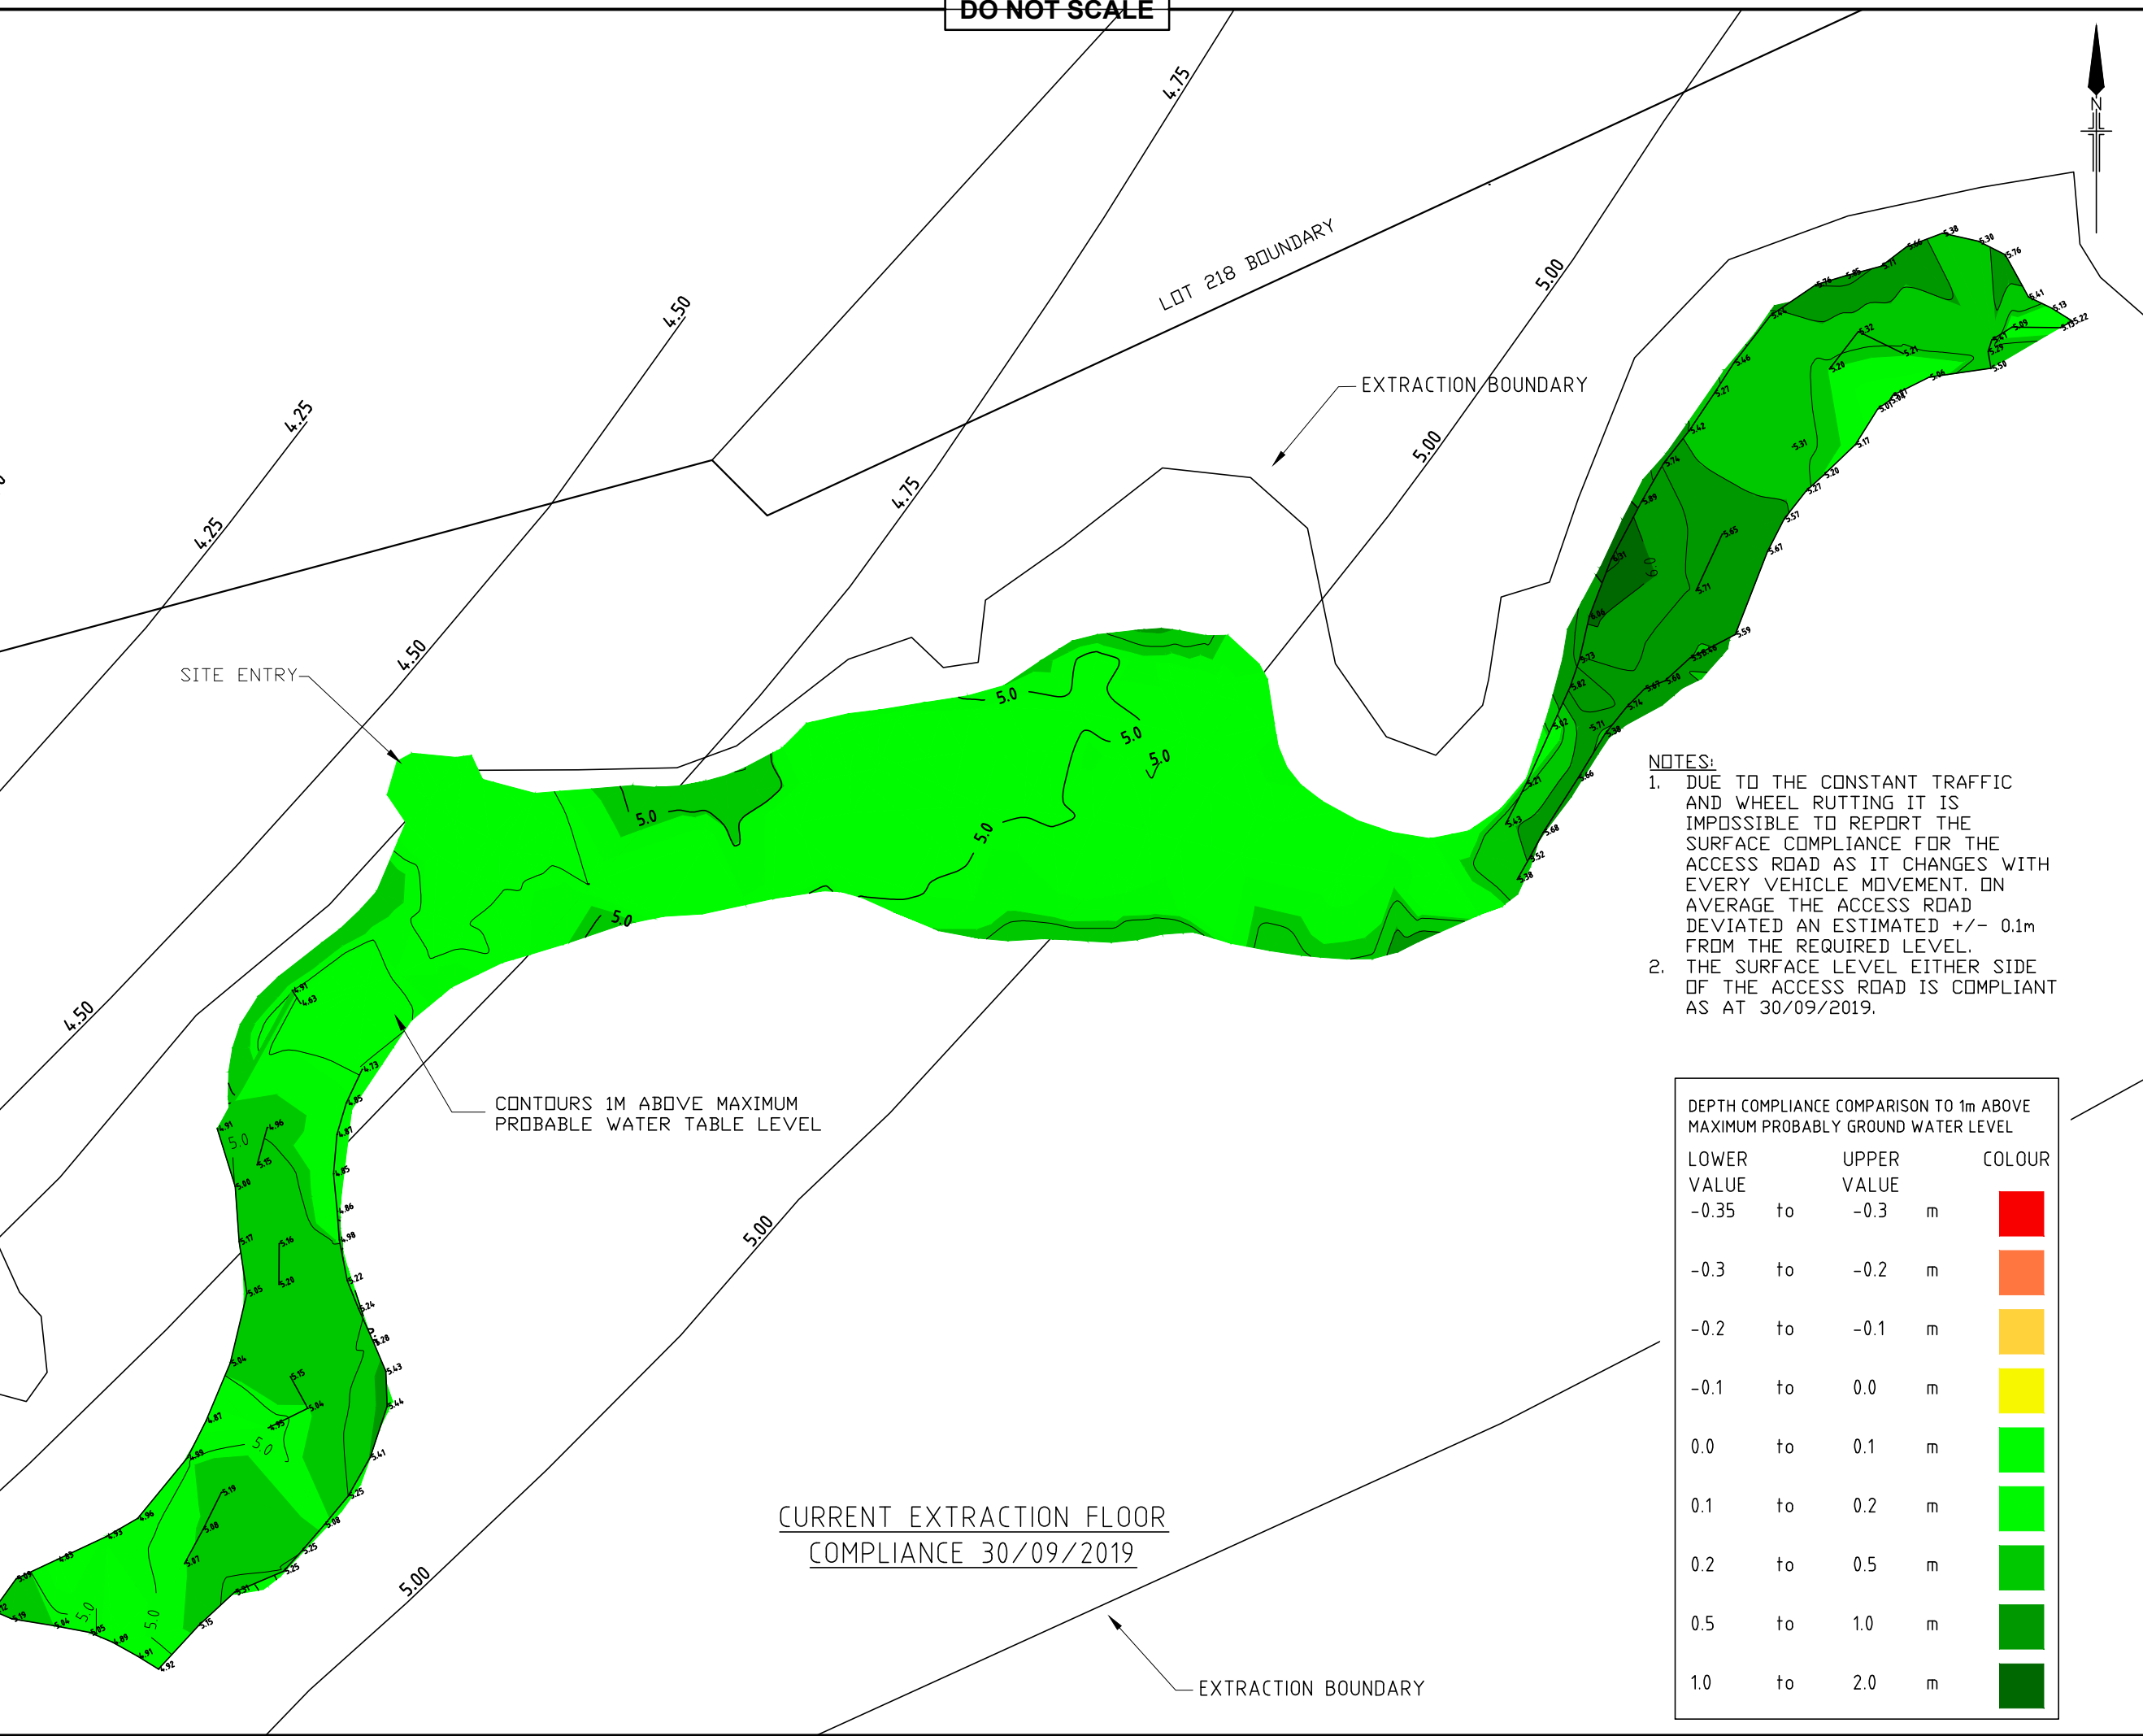
TITLE:	LOT 218 EXTRACTION LEVEL COMPLIANCE
STATUS:	SEPTEMBER 2019
DRAWING NUMBER:	
SHEET 1 OF 1 SHEETS	
A3

DEPTH COMPLIANCE COMPARISON TO 1m ABOVE MAXIMUM PROBABLE GROUND WATER LEVEL				
LOWER VALUE		UPPER VALUE		COLOUR
-0.35	to	-0.3	m	 
-0.3	to	-0.2	m	 
-0.2	to	-0.1	m	 
-0.1	to	0.0	m	 
0.0	to	0.1	m	 
0.1	to	0.2	m	 
0.2	to	0.5	m	 
0.5	to	1.0	m	 
1.0	to	2.0	m

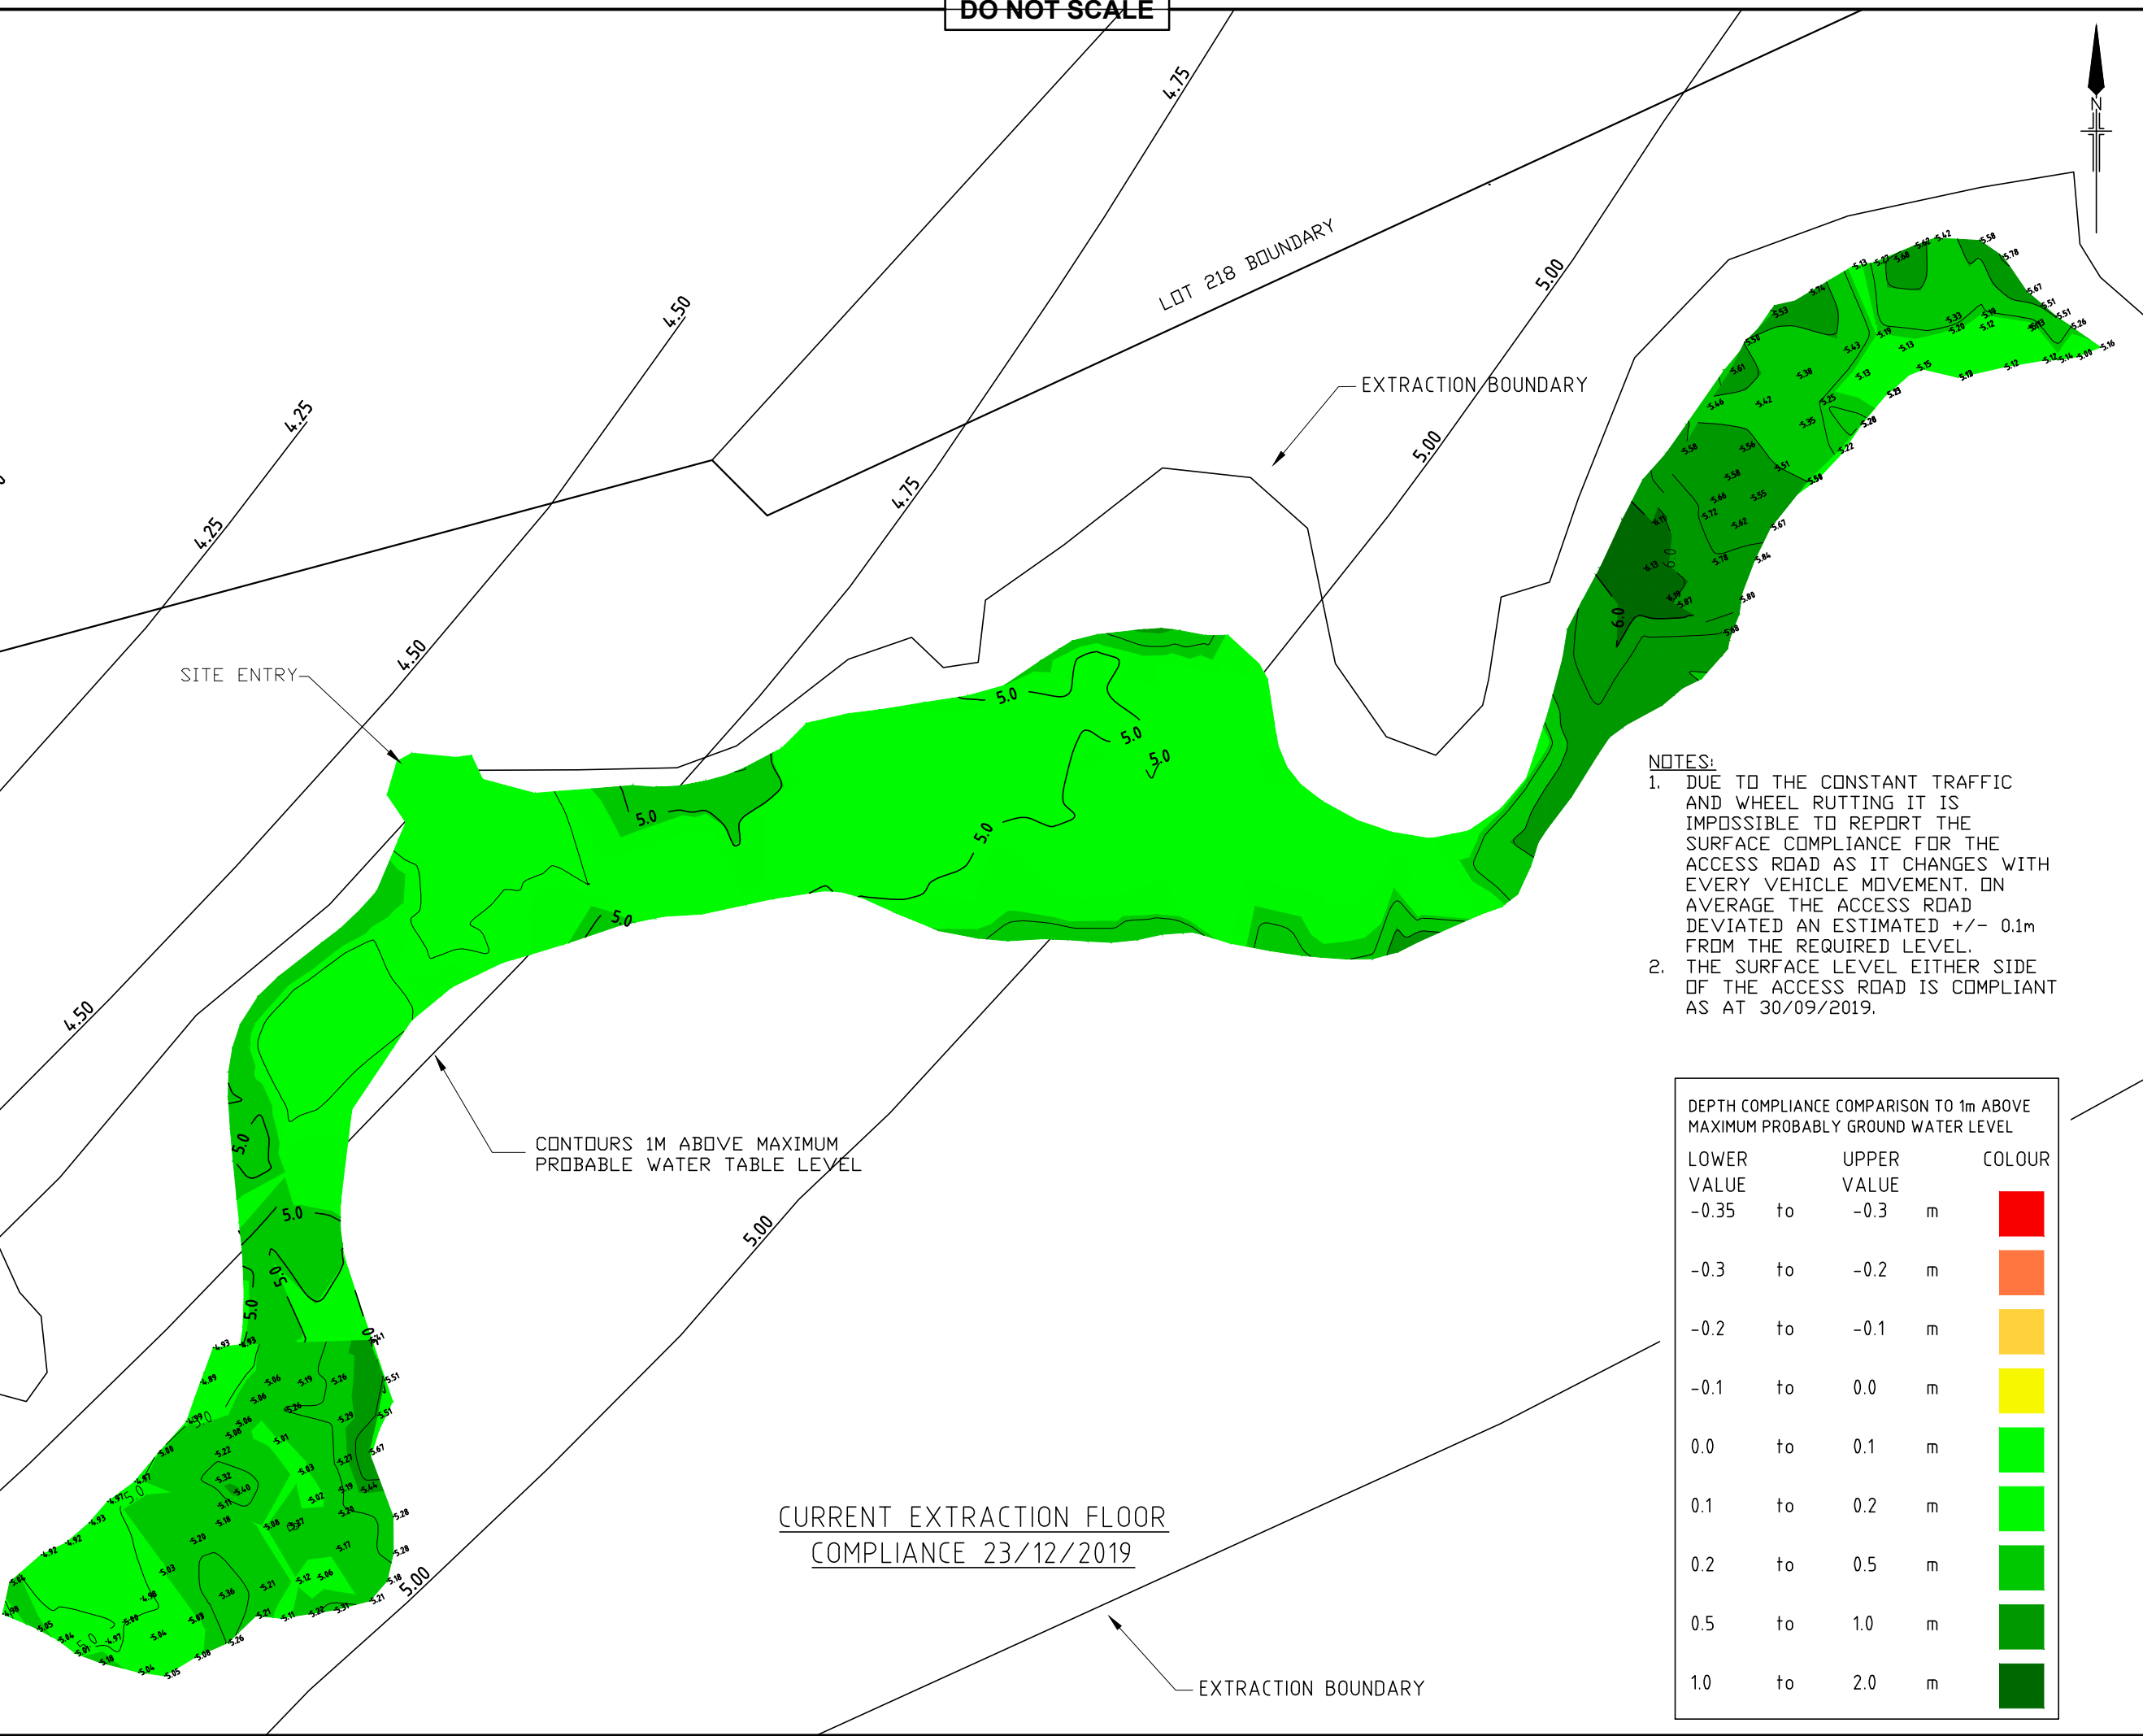
TITLE:	LOT 218 EXTRACTION LEVEL COMPLIANCE
STATUS:	DECEMBER 2019
DRAWING NUMBER:	
SHEET 1 OF 1 SHEETS

DEPTH COMPLIANCE COMPARISON TO 1m ABOVE MAXIMUM PROBABLE GROUND WATER LEVEL				
LOWER VALUE		UPPER VALUE		COLOUR
-0.35	to	-0.3	m	 
-0.3	to	-0.2	m	 
-0.2	to	-0.1	m	 
-0.1	to	0.0	m	 
0.0	to	0.1	m	 
0.1	to	0.2	m	 
0.2	to	0.5	m	 
0.5	to	1.0	m	 
1.0	to	2.0	m

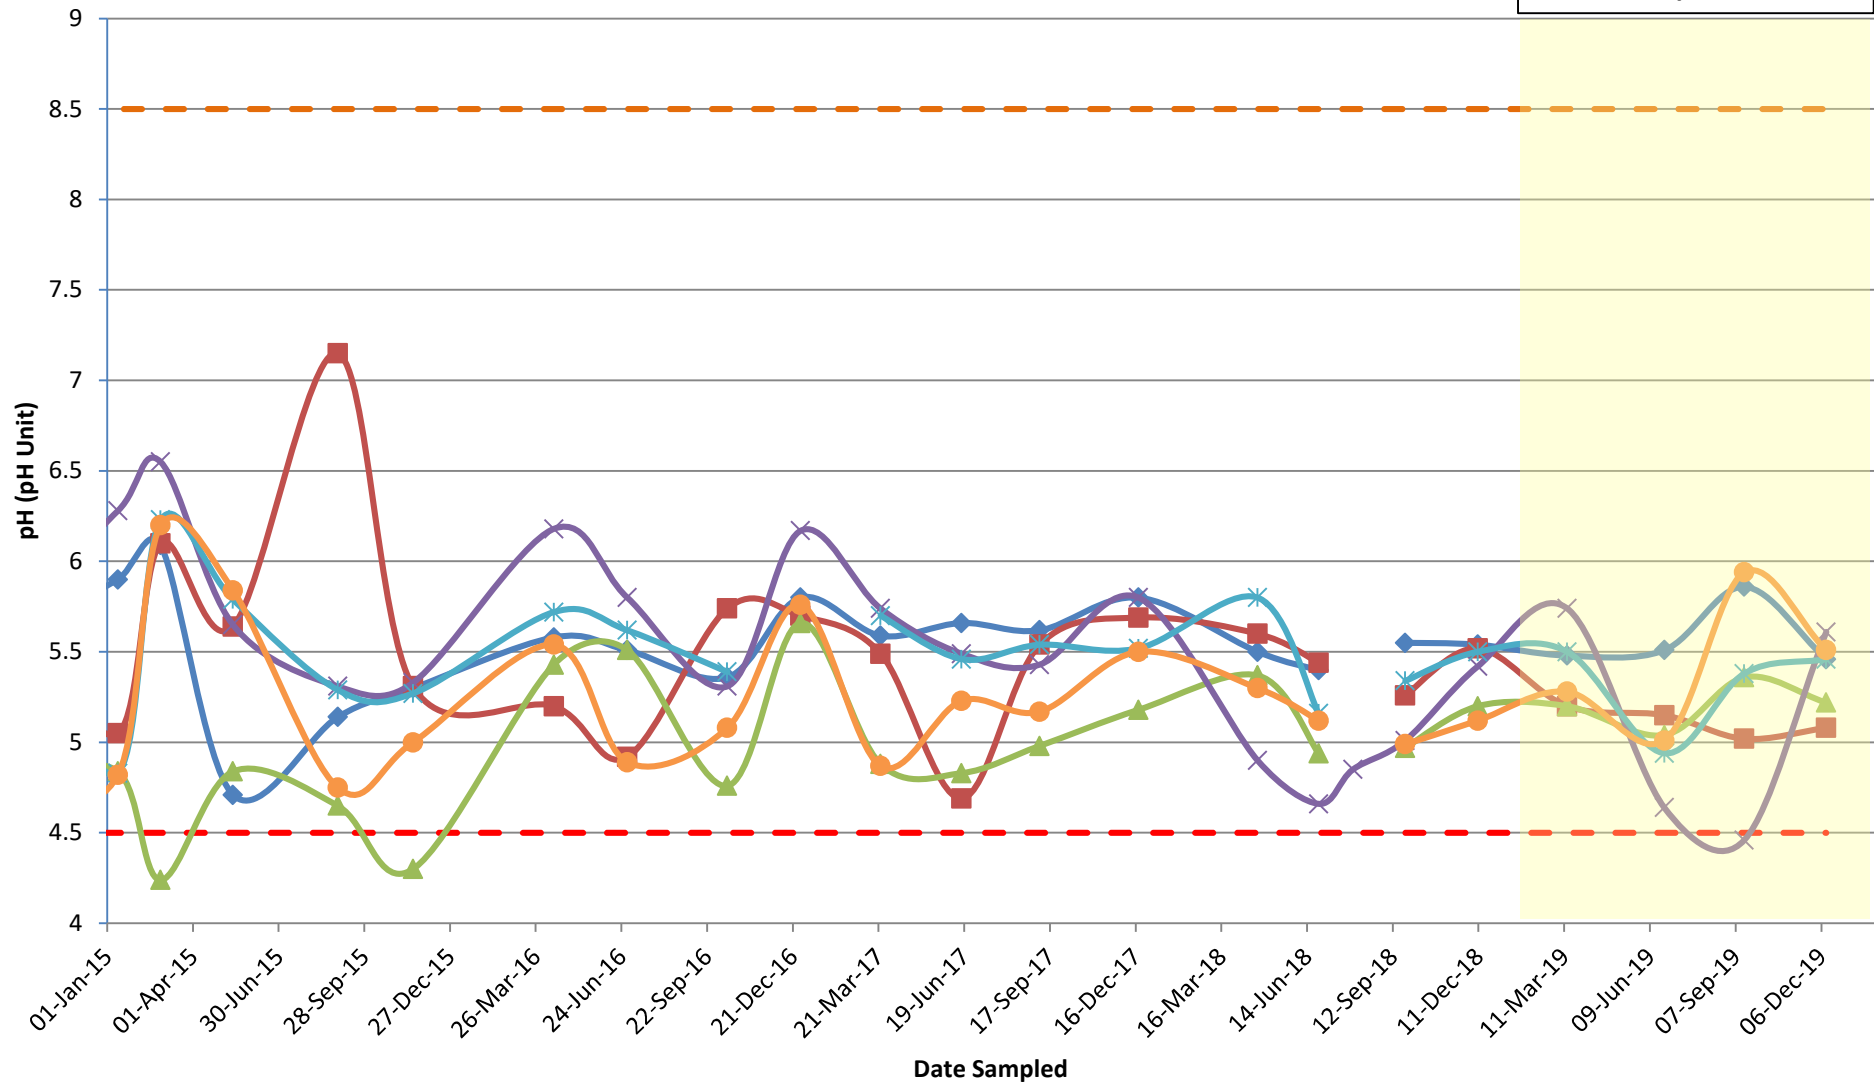
Groundwater - pH

Note: No EPL Limit Specified
