MACKAS SAND ANNUAL REVIEW 2019

January – December 2019

Prepared by
Umwelt (Australia) Pty Limited
on behalf of
Mackas Sand Pty Ltd

Project Director: **Bret Jenkins**
Project Manager: **Rod Williams**
Report No. **1646/R95**
Date: **March 2020**

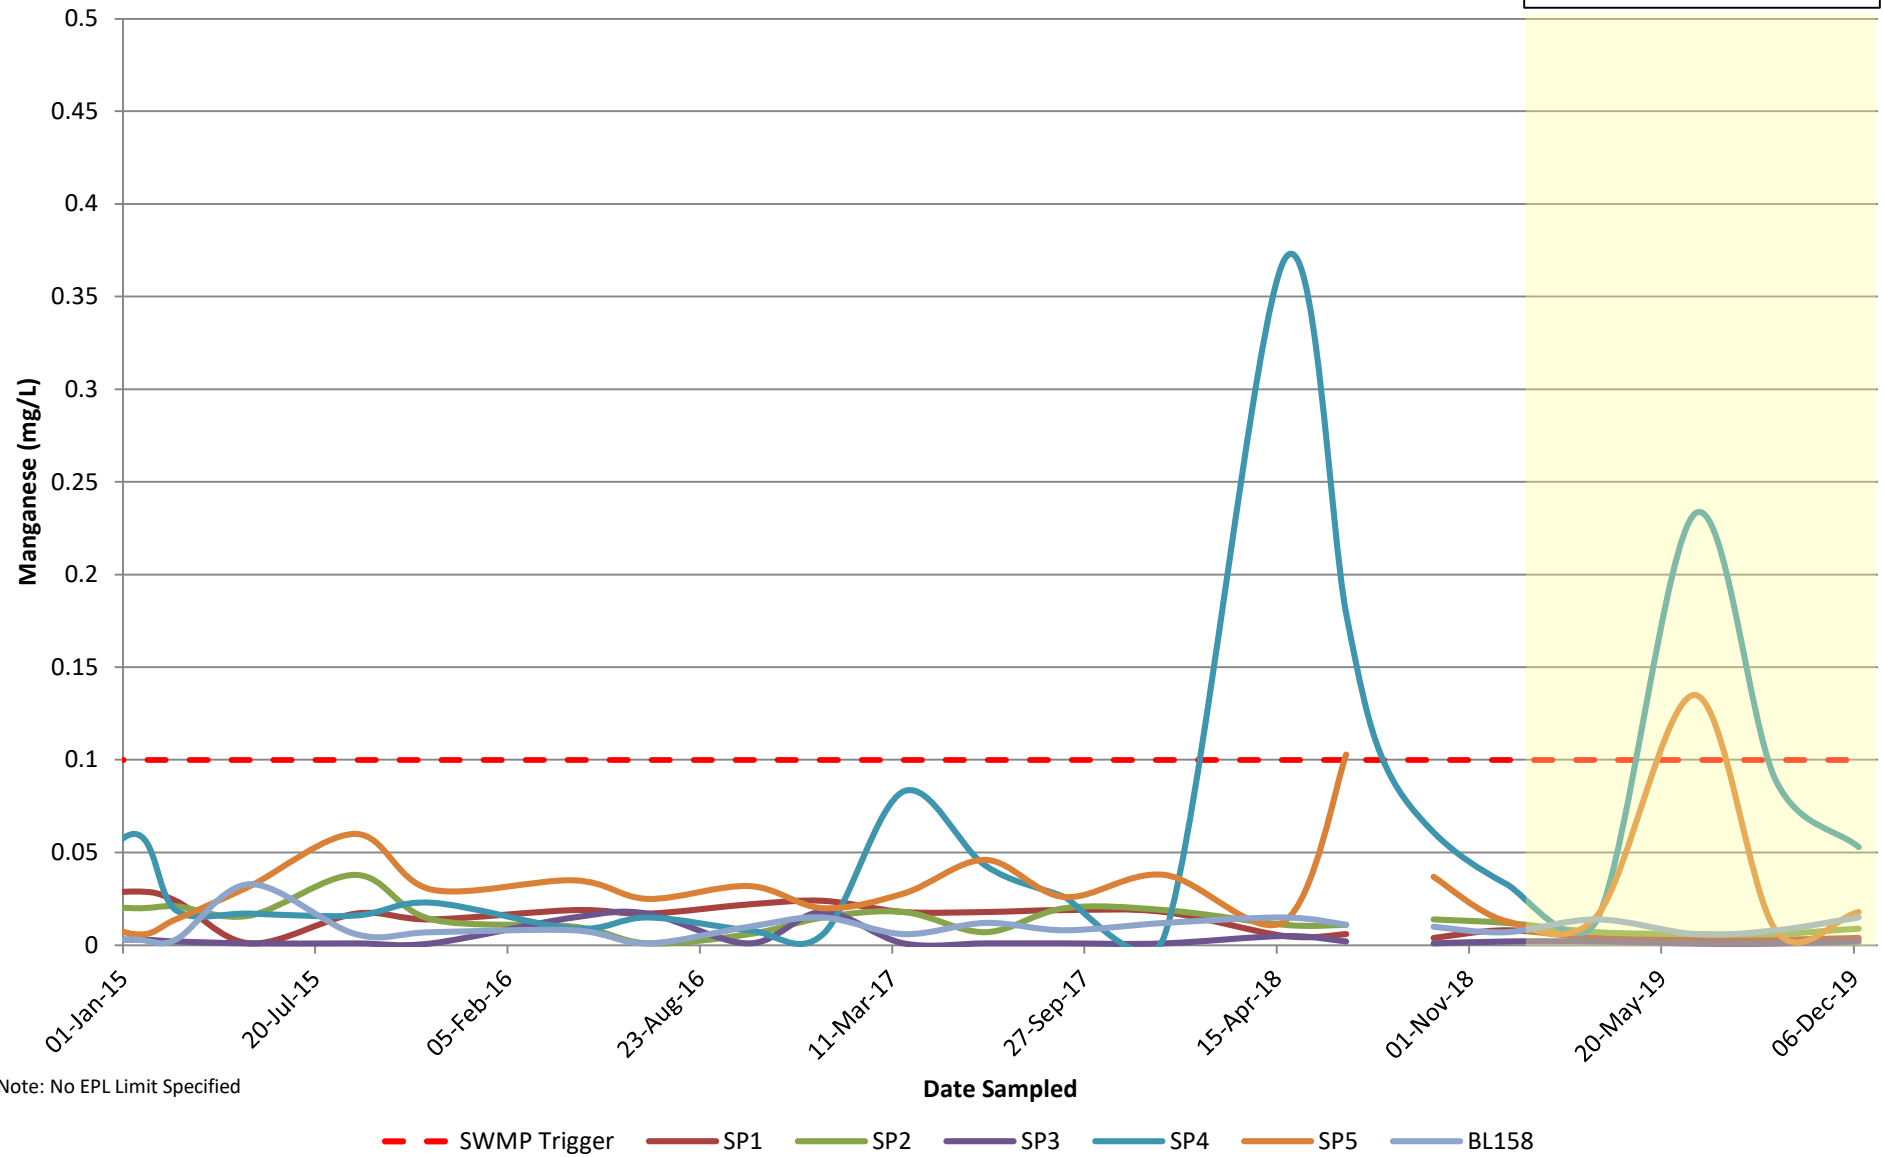
Groundwater - Manganese (mg/L)

Note: No EPL Limit Specified

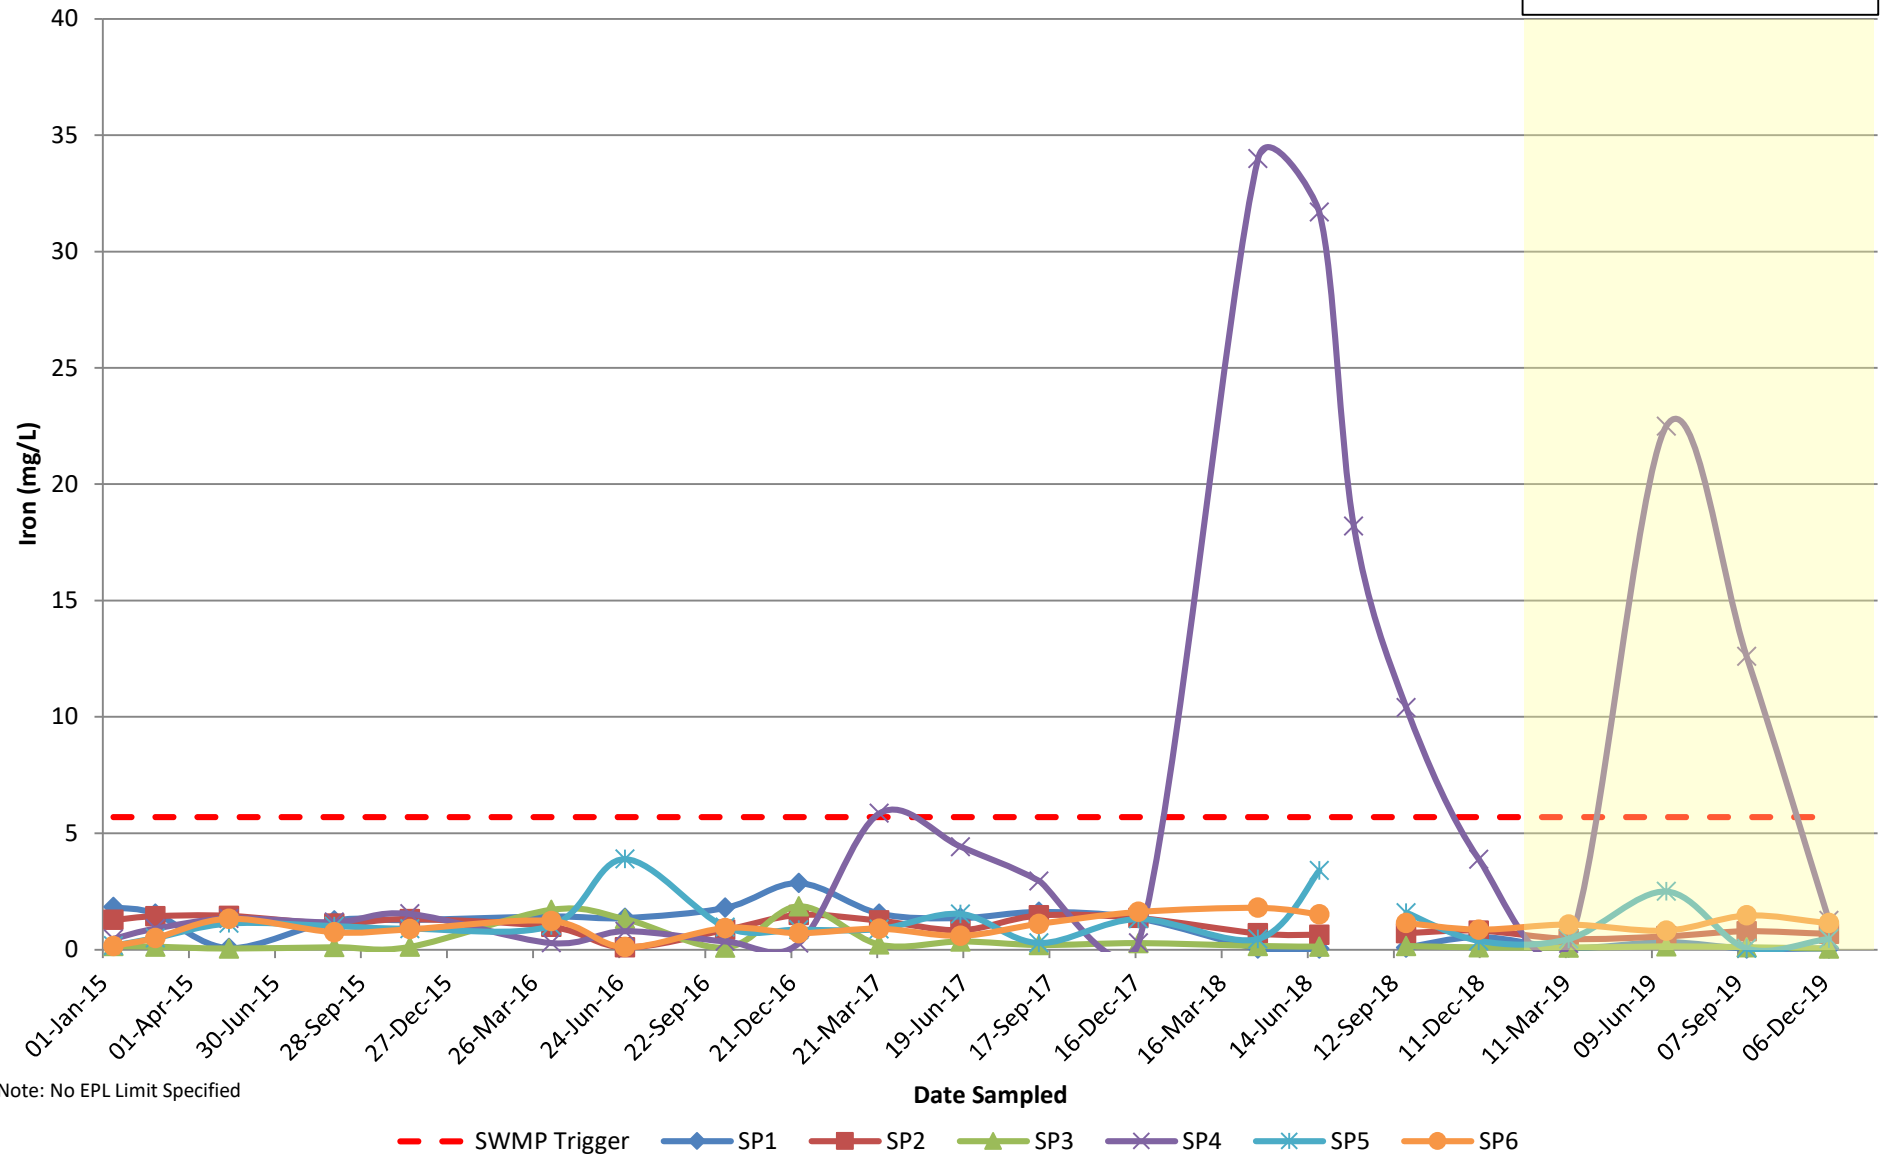
Groundwater - Iron (mg/L)

Note: No EPL Limit Specified
